HWA (Structural Engineers) Limited

20646/BGS- L -01

## **St John the Baptist Church, Hammerwich – Structural Inspection of Churchyard boundary walls and structures.**

## St John the Baptist Churchyard Hammerwich - Photographs

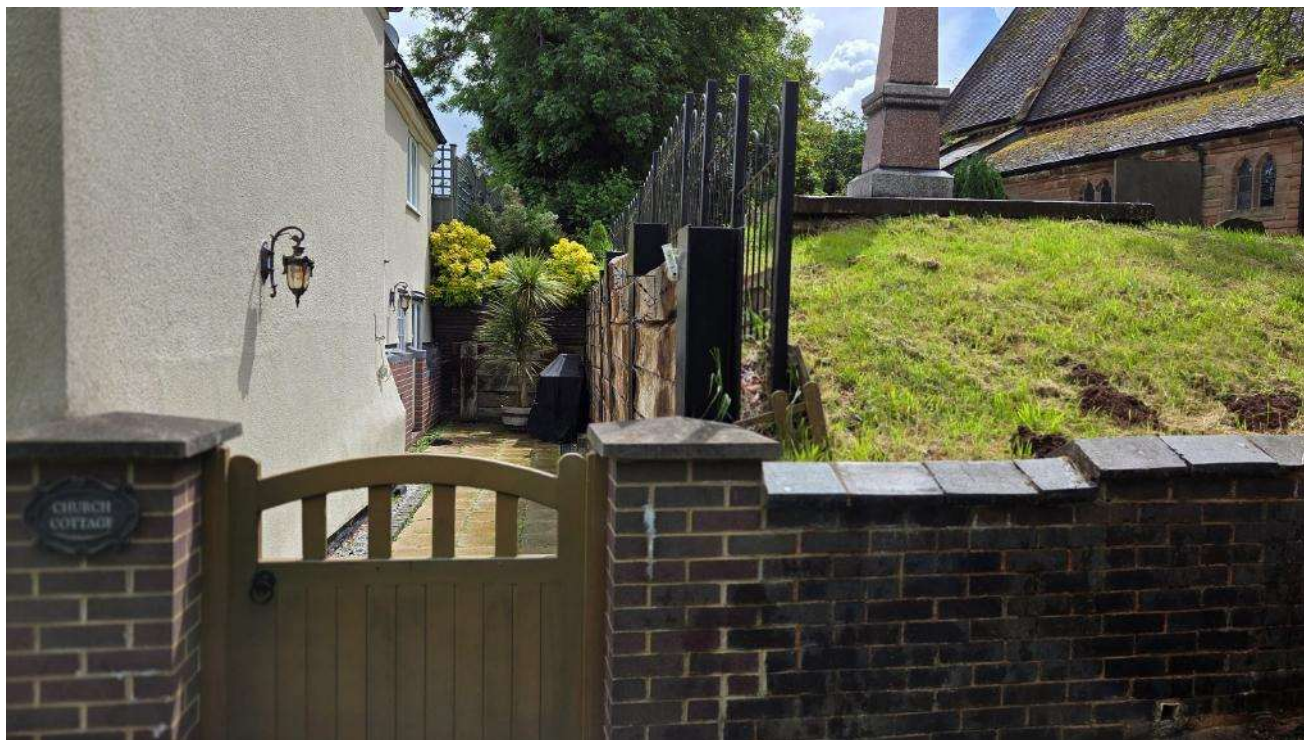
- 4.1 We understand that this retaining wall is not owned by the church but retains a significant section of the churchyard, particularly a significant monumental grave above that shows some movement at its pedestal base.
- 4.2 The wall comprised steel column uprights embedded into the ground with horizontal timber sleepers between supporting the ground. The wall is leaning towards the house. It is unclear if this movement has stopped.
- 4.3 Whilst the responsibility for its maintenance may be with others it does support graves that show defects and some instability.

1) Steel post and timber sleeper retaining wall with monumental grave above.

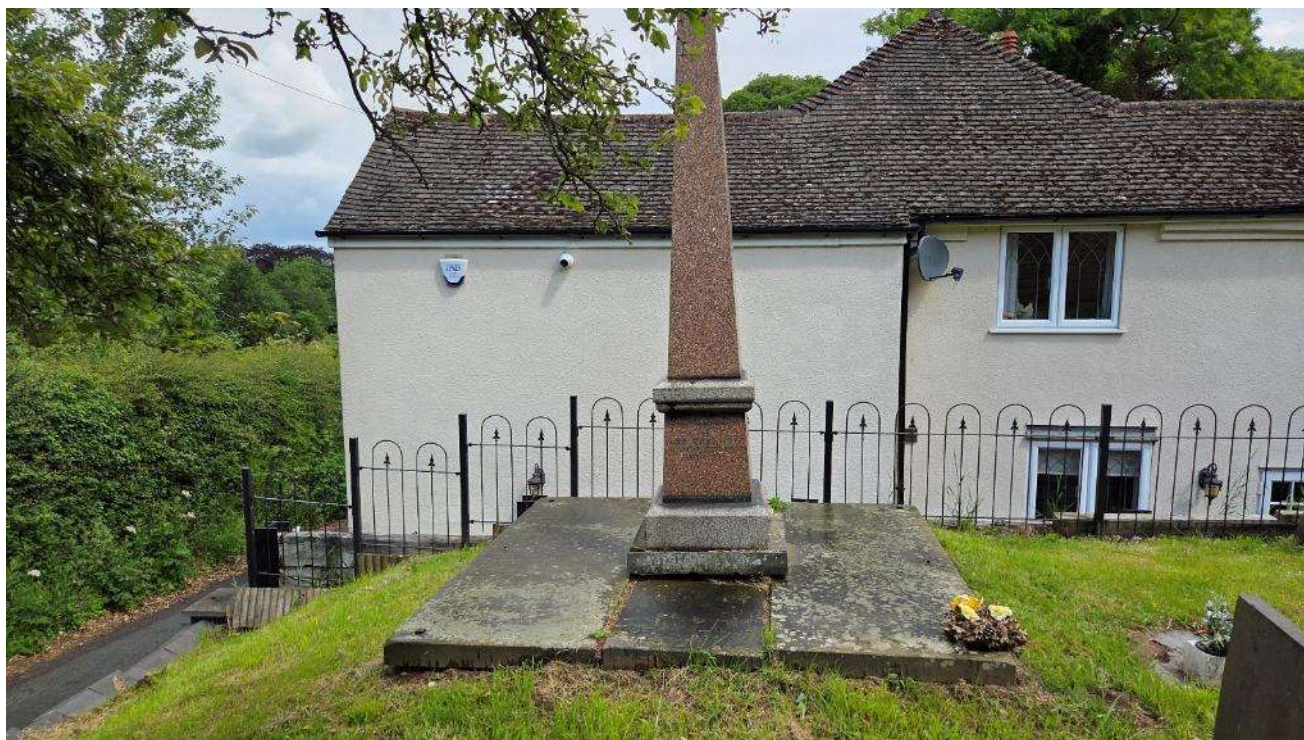
9.7 The base of the tall monument grave at the NW corner has settled in part although the main tall stone was stable. This is adjacent to the Church Cottage retaining wall. Refer to Photographs 1-3.

2) View looking north with base of grave settling and displacing slightly.

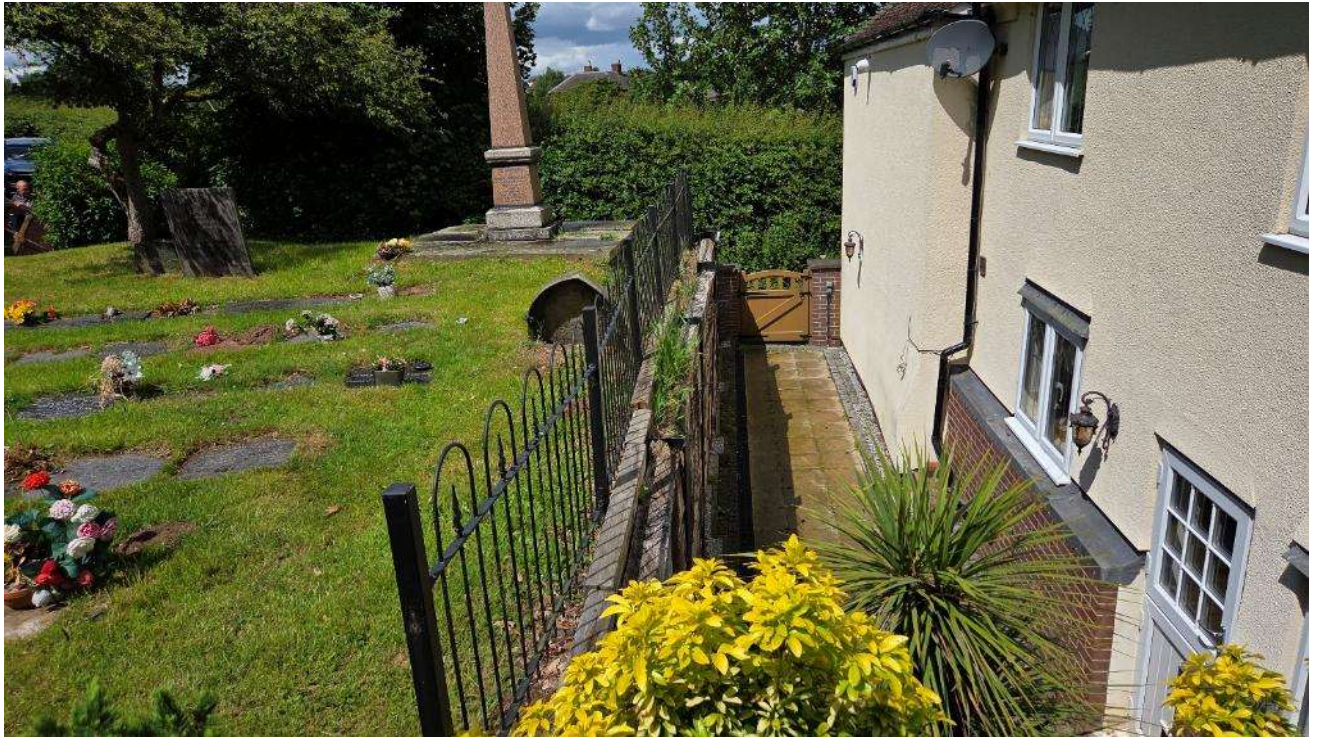
3) View looking west with graves close to retaining wall.

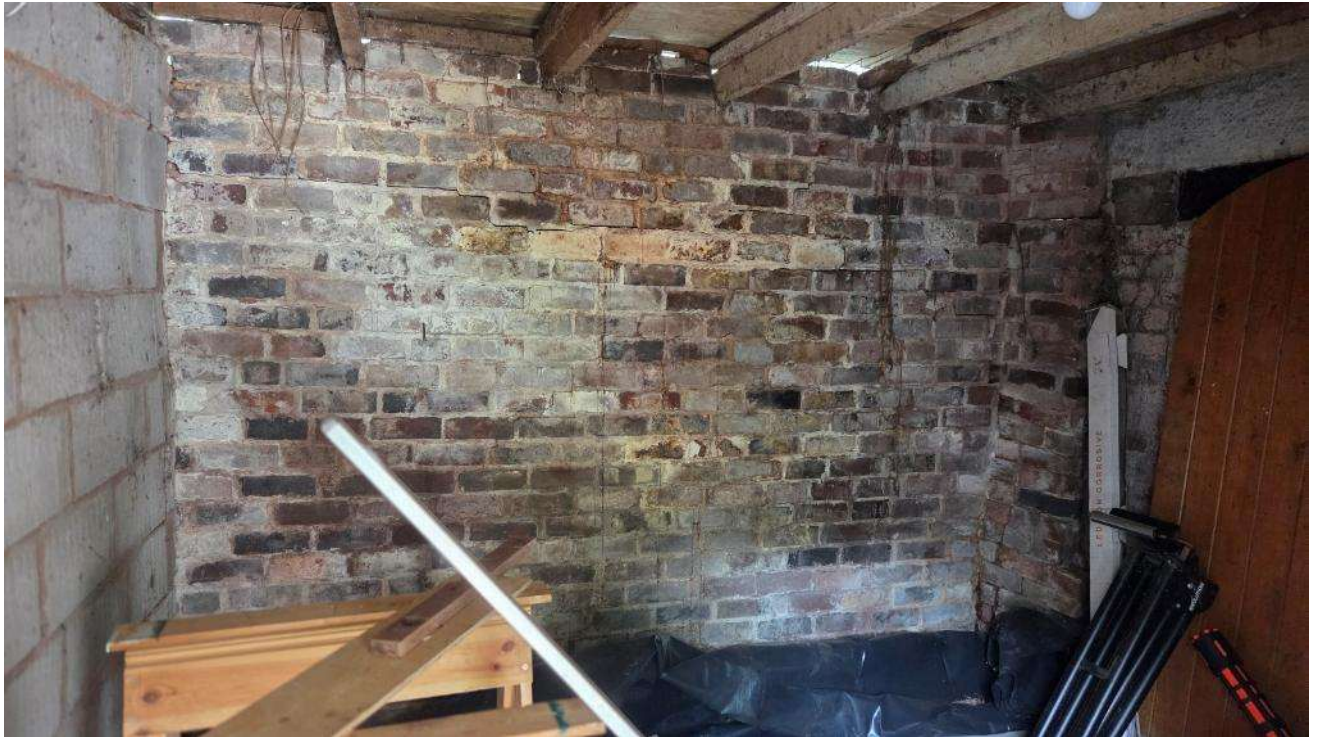
- 5.3 The wall bows inwards before rotating back where it is propped by the roof timber joists. The height of the wall leaning above the floor on the left hand side is approximately 1.67m. There is a near horizontal crack or opening up of the masonry at this level across the width of the wall although it does step slightly down towards the right. The crack was approximately 0.5-1mm at the centre, which is considered slight, but with the bowing of the wall the defects are more onerous.

- 5.7 The floor comprising brick sets has been taken up and a new concrete slab cast close to the wall retaining a few sets near the base of the wall.
- 5.8 The wall is failing due to the pressure from the retained earth of the churchyard.

5) Rear wall of outbuilding forms the boundary retaining wall. Wall is bowed and cracked.

- 3.2 The bowing and extensive cracking to the boundary wall within an outbuilding of the Old Rectory and corner of Church Cottage is similarly difficult to remediate. With graves also present close to the rear of the wall. In order to not disturb graves would require support to be provided within the owner's property. Please note that the outbuilding whilst old may be younger than the retaining wall. The brick flooring has recently been dug up and replaced with a concrete floor in part.

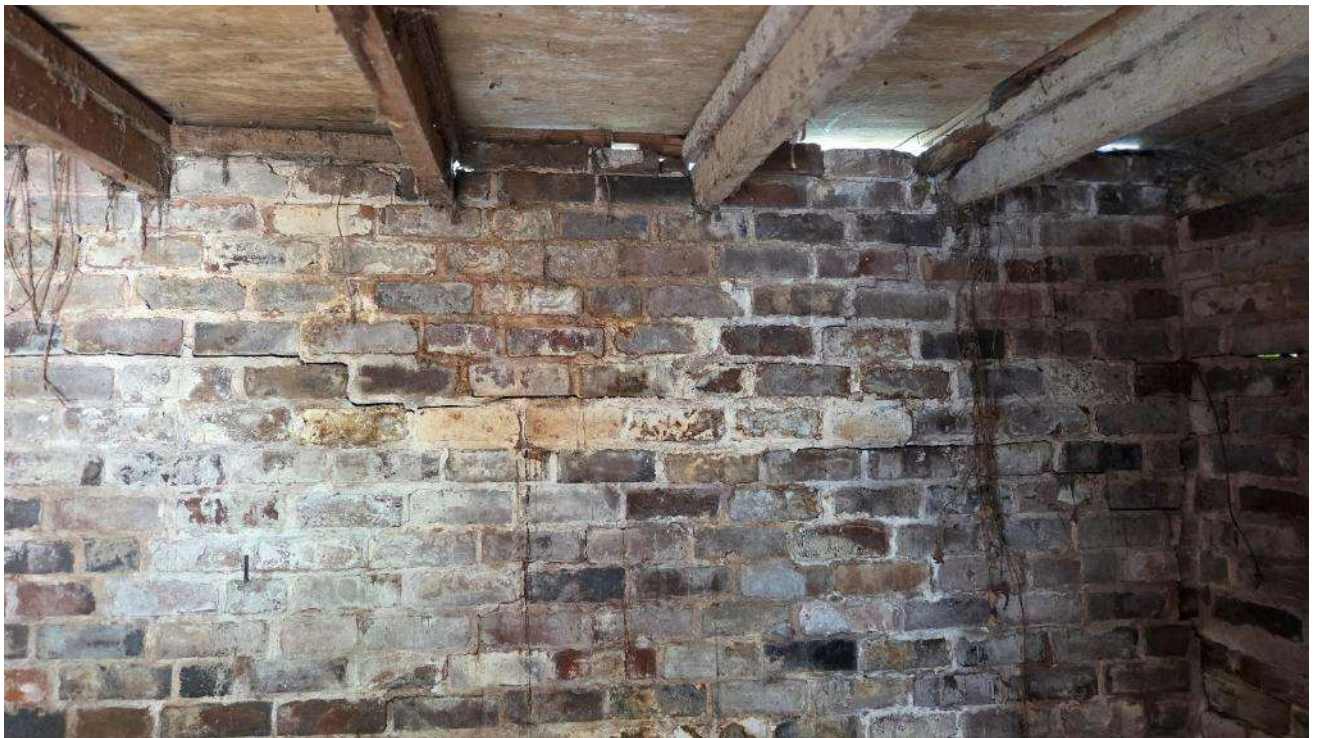
- 5.4 Salts are present to the surface of the brickwork at and above the horizontal crack line indicating damp ingress.
- 5.5 Near the centre of the wall panel there are a series of stepped diagonal cracks from the horizontal crack that peter out lower down and two are only hairline in nature.

6) Horizontal cracks to face of retaining wall.

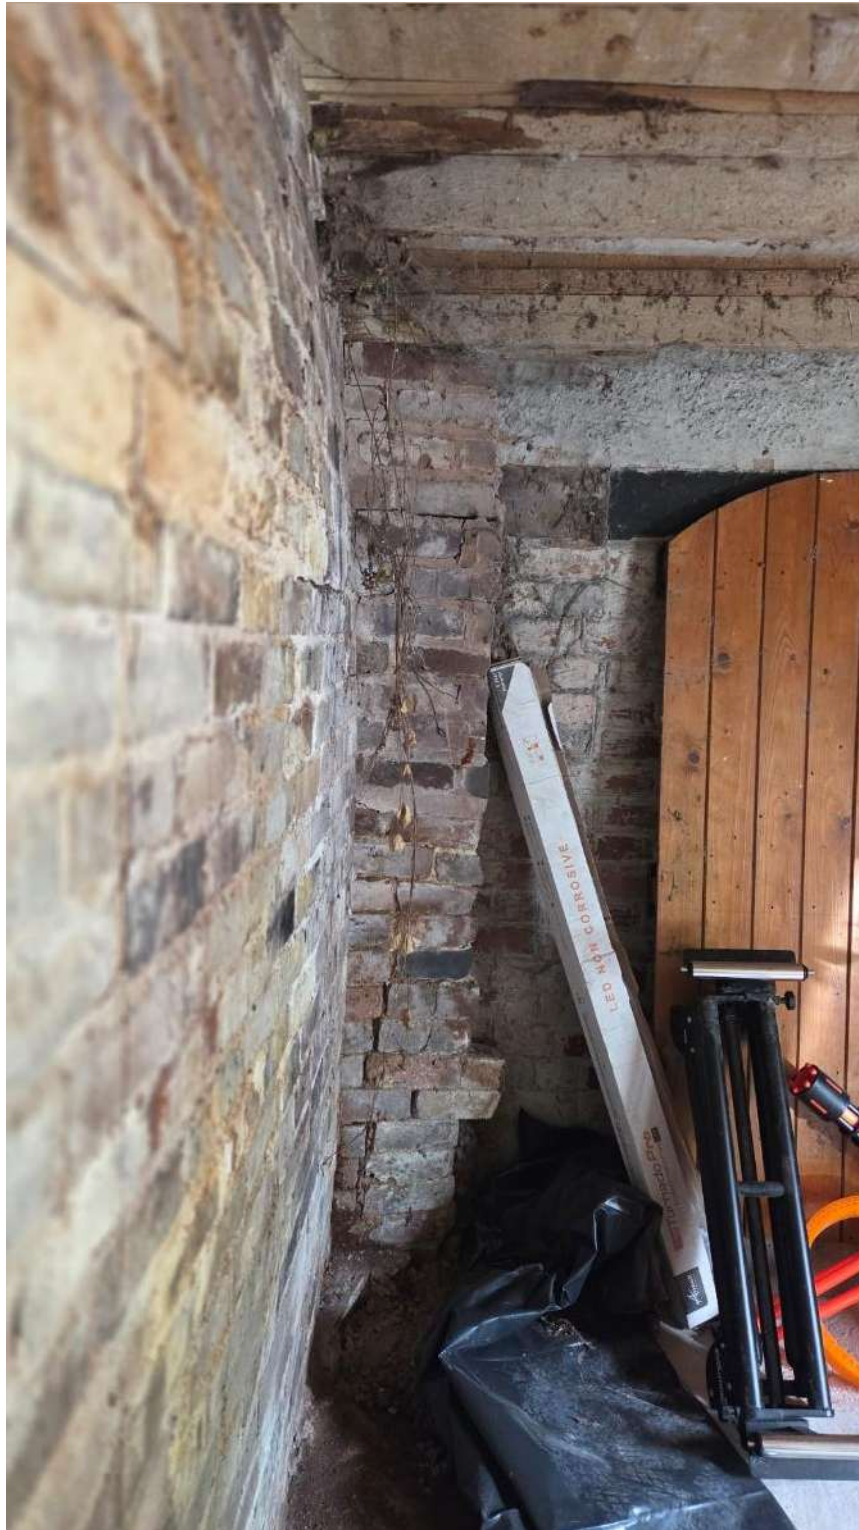
7) Bulge in retaining wall looking west, with cracked buttress wall to Cottage.

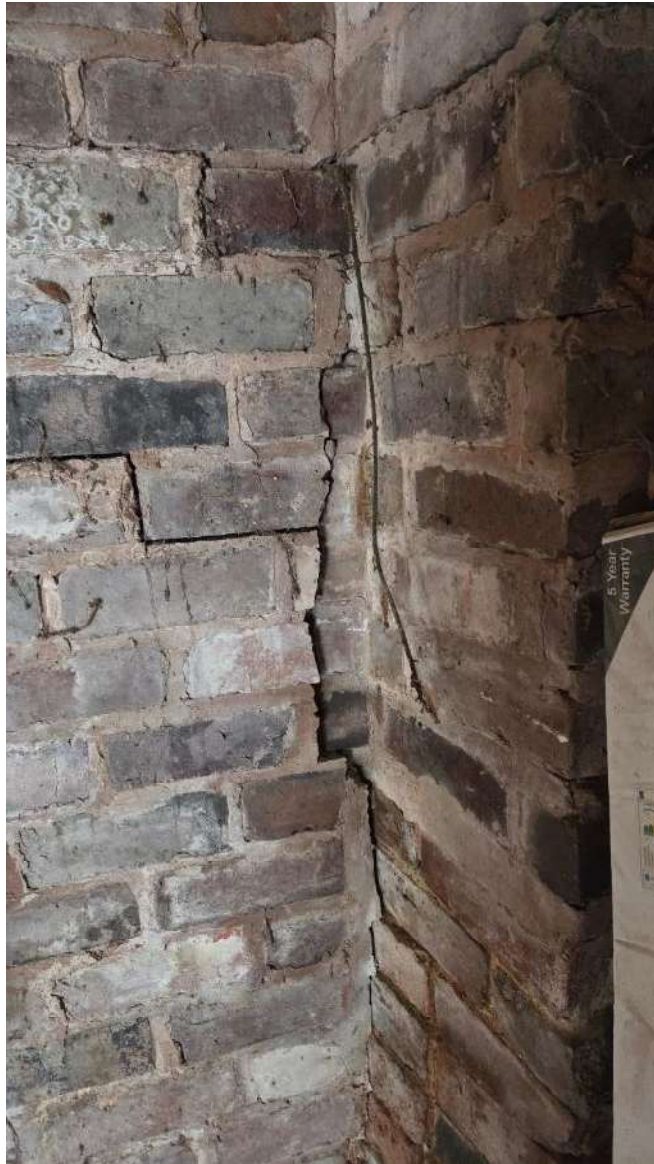
- 5.6 To the right-hand side, the brickwork has sheared just before the return forming a near vertical crack which does step and link to the horizontal crack. The return brickwork section is also cracked with light from the courtyard to Church Cottage visible through the wall.

8) Cracking and displacement of wall adjacent to return brickwork at west end of outbuilding

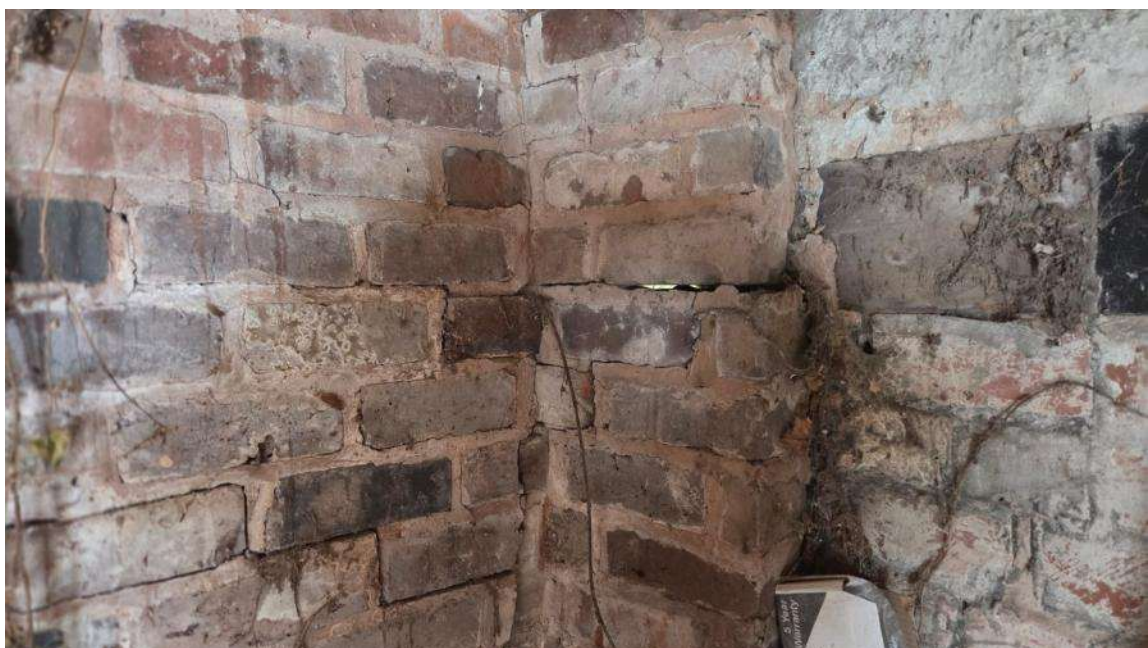
9) Further view of cracking and wall displacement at the west corner.

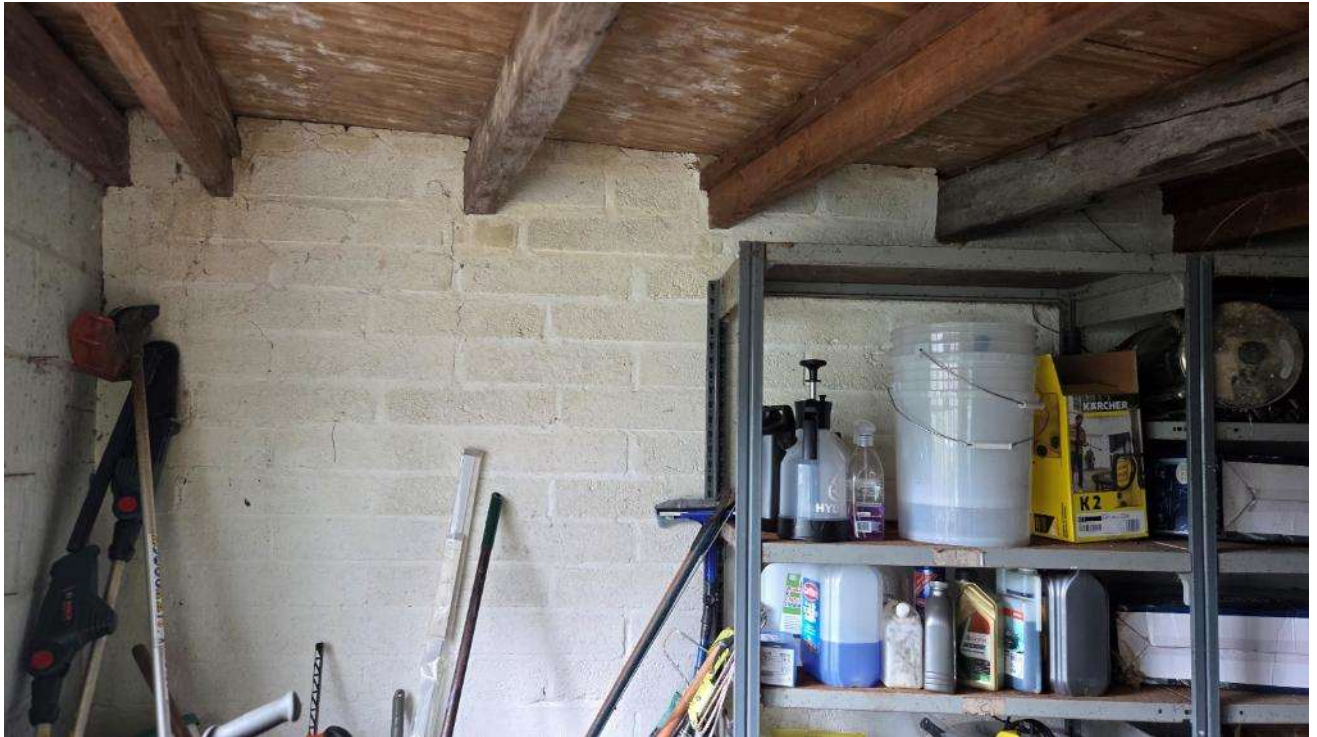
- 5.9 The adjacent room does not show any significant defects as a new blockwork wall has been built in front of the retaining wall. That is not to say that there are similar defects to the original wall.

10) Eastern section of outbuilding; retaining wall obscured by new block wall built in front.

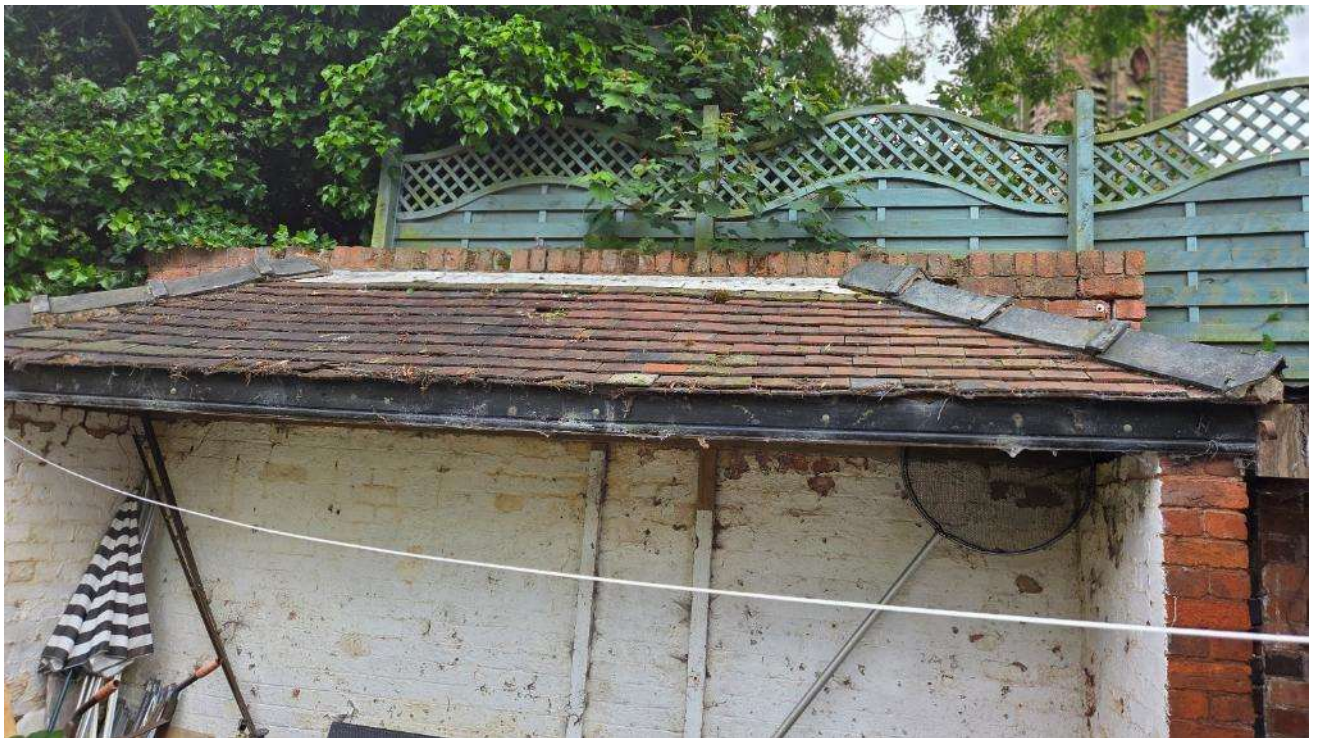
- 5.10 The open side store has two brick buttress walls at either end. There are few structural defects of any significance. Above the narrow-tiled roof there are a few cracks through the mortar courses and frost damage. The left-hand flank wall has a stepped diagonal crack beneath the roof, but this is still near the top of the wall.

11) Open sided “store” with cracks to top of the wall by the fence.

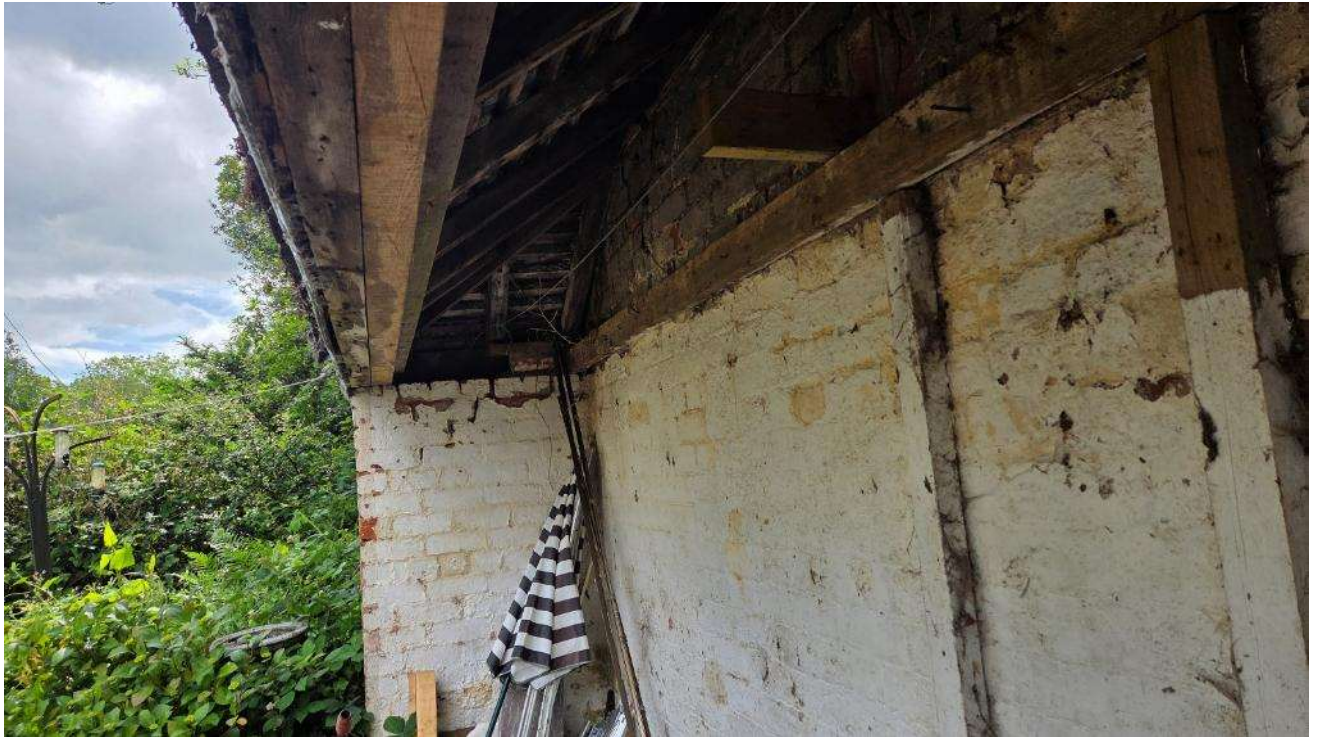
12) Minor diagonal cracks to brickwork buttress at the store.

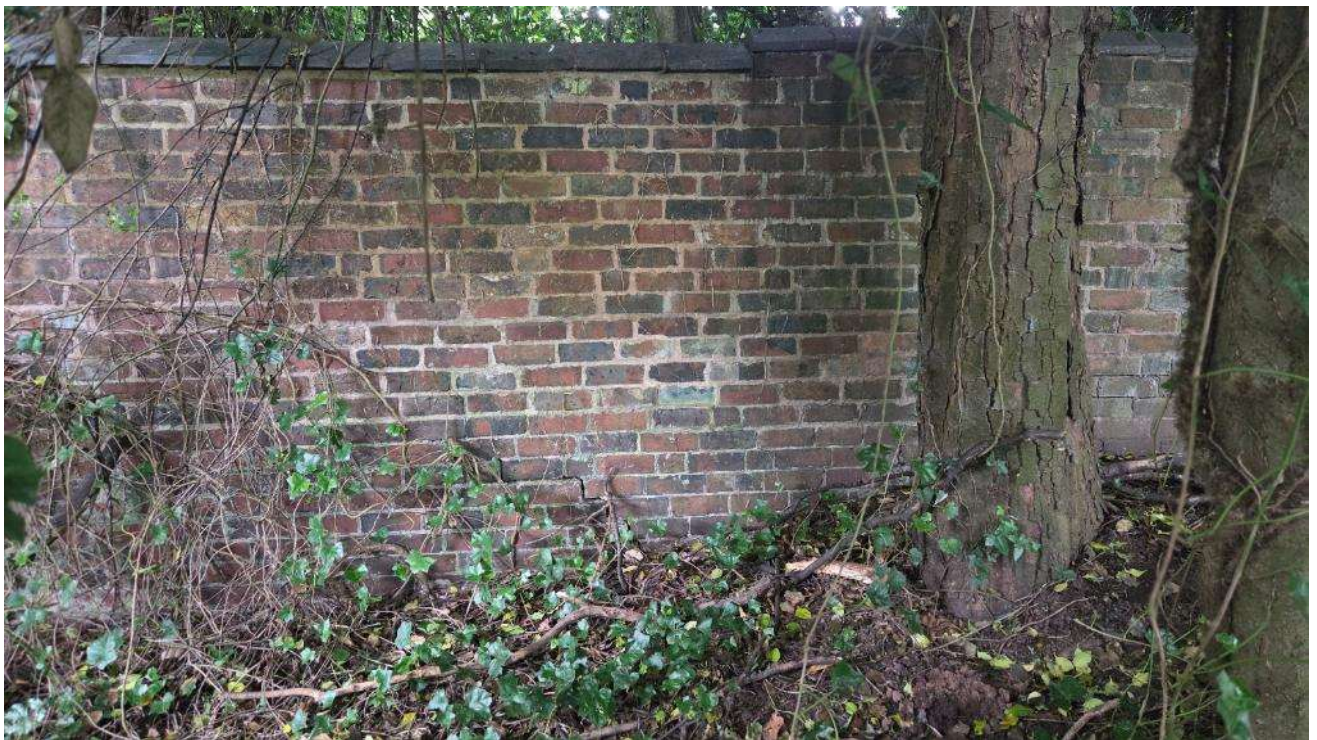
15) Crack to base of wall the bottom section has displaced slightly into the garden.

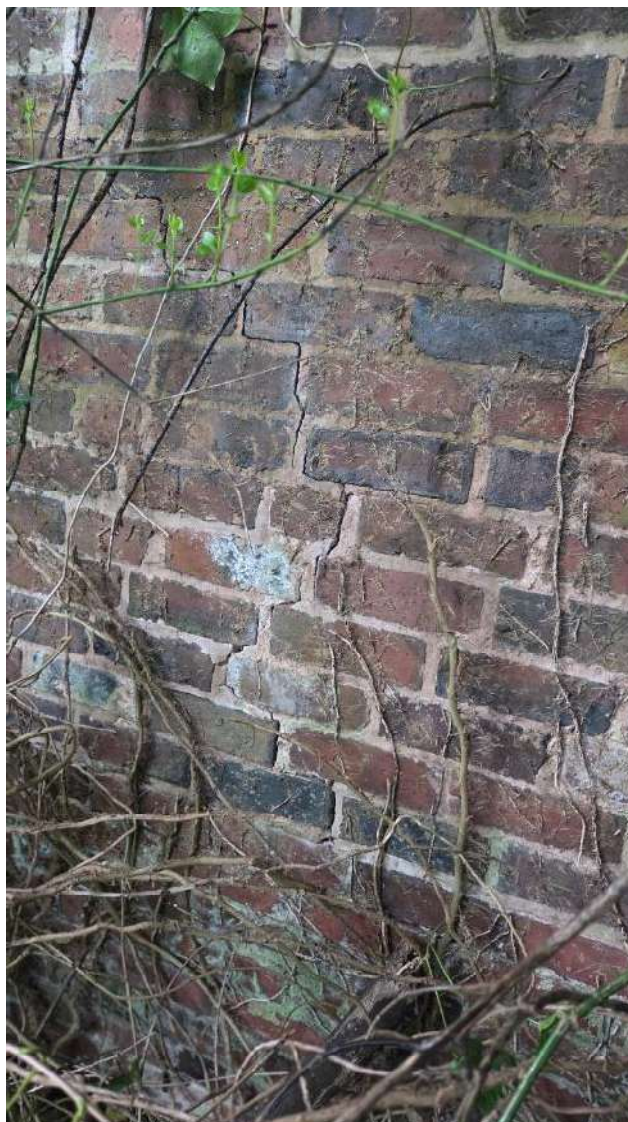
- 5.12 There are a few relatively minor cracks interspaced along this northern wall. These are likely to be as result of ground movement from trees and vegetation growth either side of the wall. Lots of ivy has grown over from the churchyard but there are signs of previous growth having been cut back from The Old Rectory side.

16) Further cracks along wall to the east.

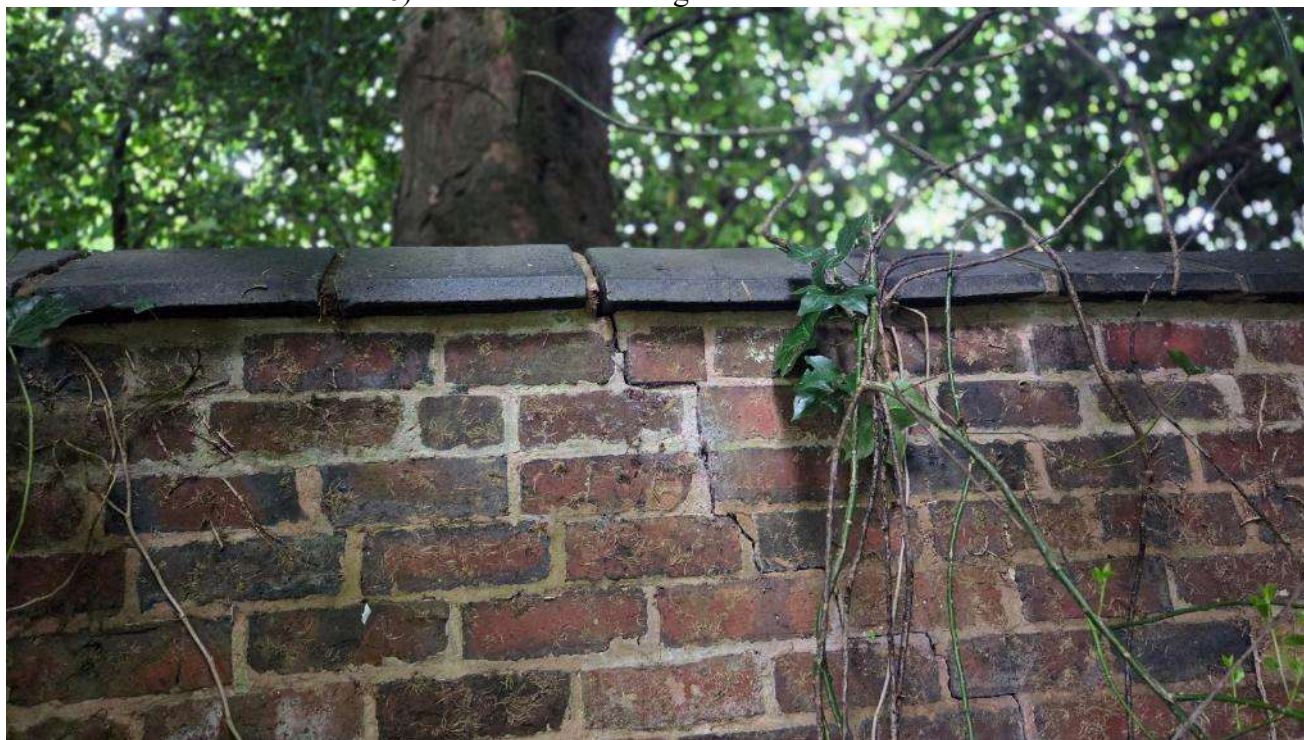
17) Minor crack through mortar joints and coping stone joints.

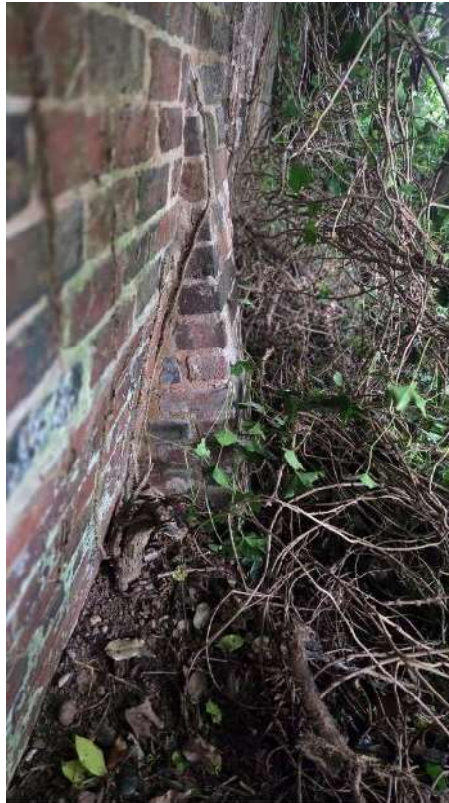
- 5.13 There are some low-level buttresses present where the bottom of the wall appears to lean outward, (away from the churchyard). This would suggest that there may be an older section of wall lower down with a newer section built above, although there is not any obvious change in brickwork or mortar.

18) Small buttress with wall at base having rotated towards garden.

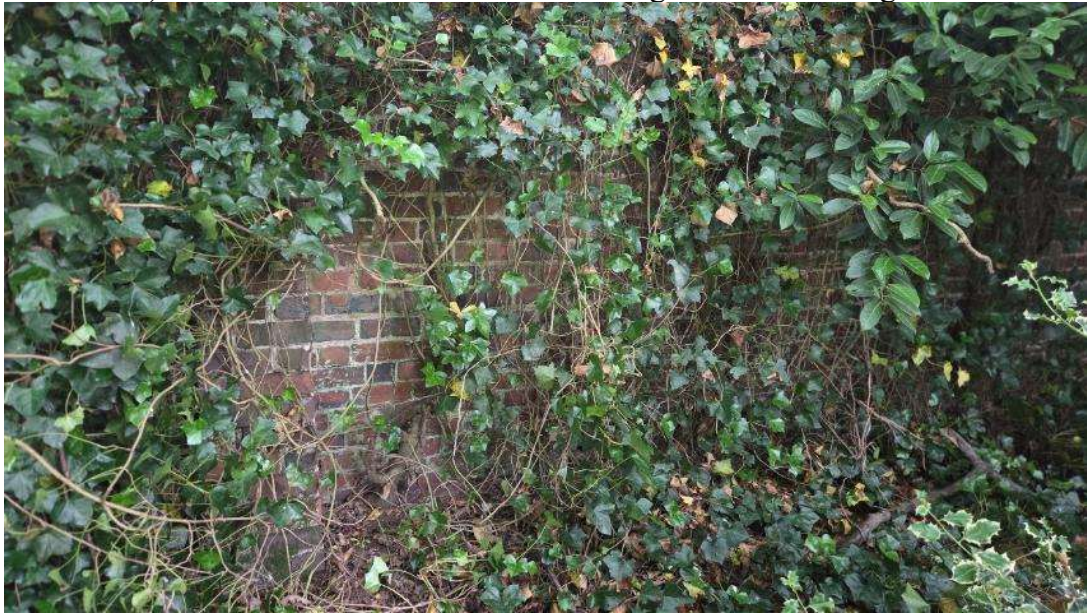
19) Typical vegetation growth from both churchyard side and garden with minor cracks and loos of mortar at cleared patch.

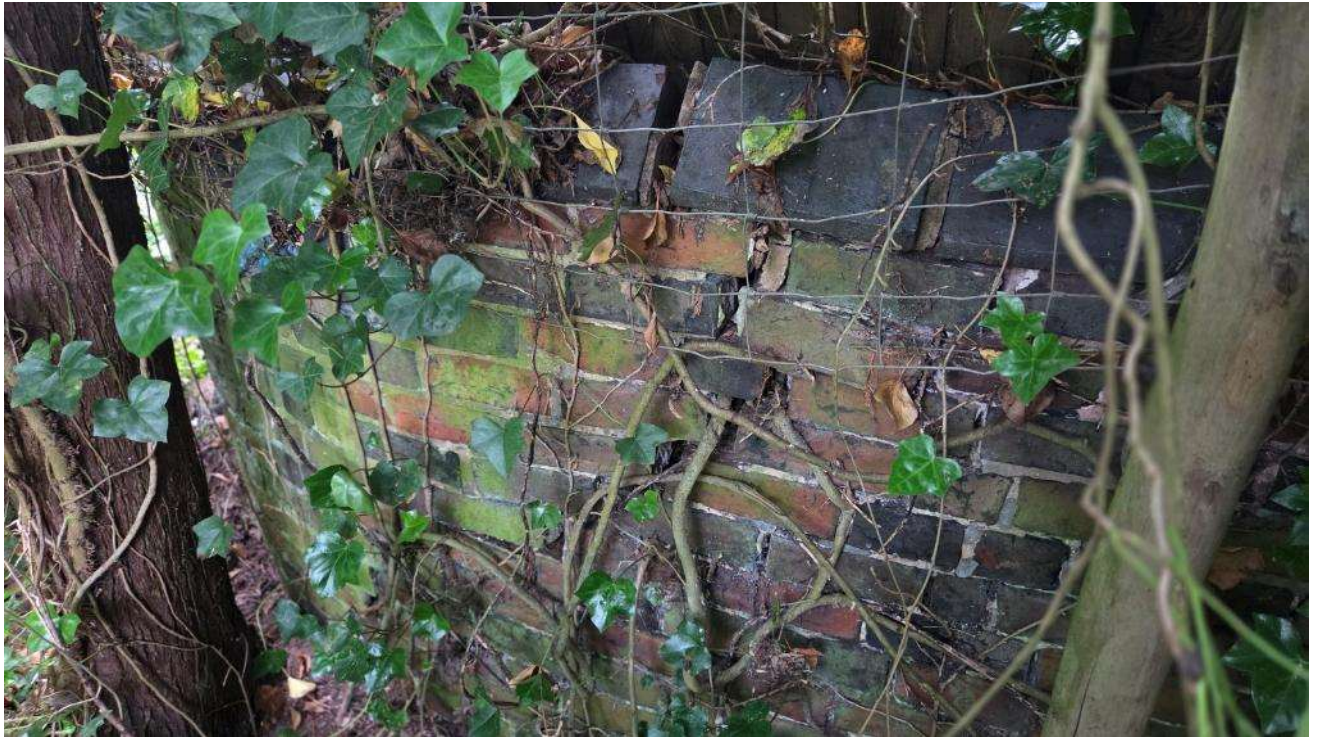
- 3.3 The brick wall section at the NE corner of The Old Rectory garden has partially collapsed and is leaning on either side. The multitude of trees on either side of the wall at this location would appear to be the cause and, in this case, one on the neighbour's side being a main culprit. Whilst not directly in the vicinity of the general public it should be taken down to a lower level.

- 5.14 Prior to the NE corner, the wall reduces in height, but the curved corner is severely damaged with collapsing sections. There are several trees in close proximity, but a large tree grows very

20) Severely cracked and rotated lower wall section at the NE corner.

close to the base of the wall on The Old Vicarage side. The wall should be dismantled in this corner.

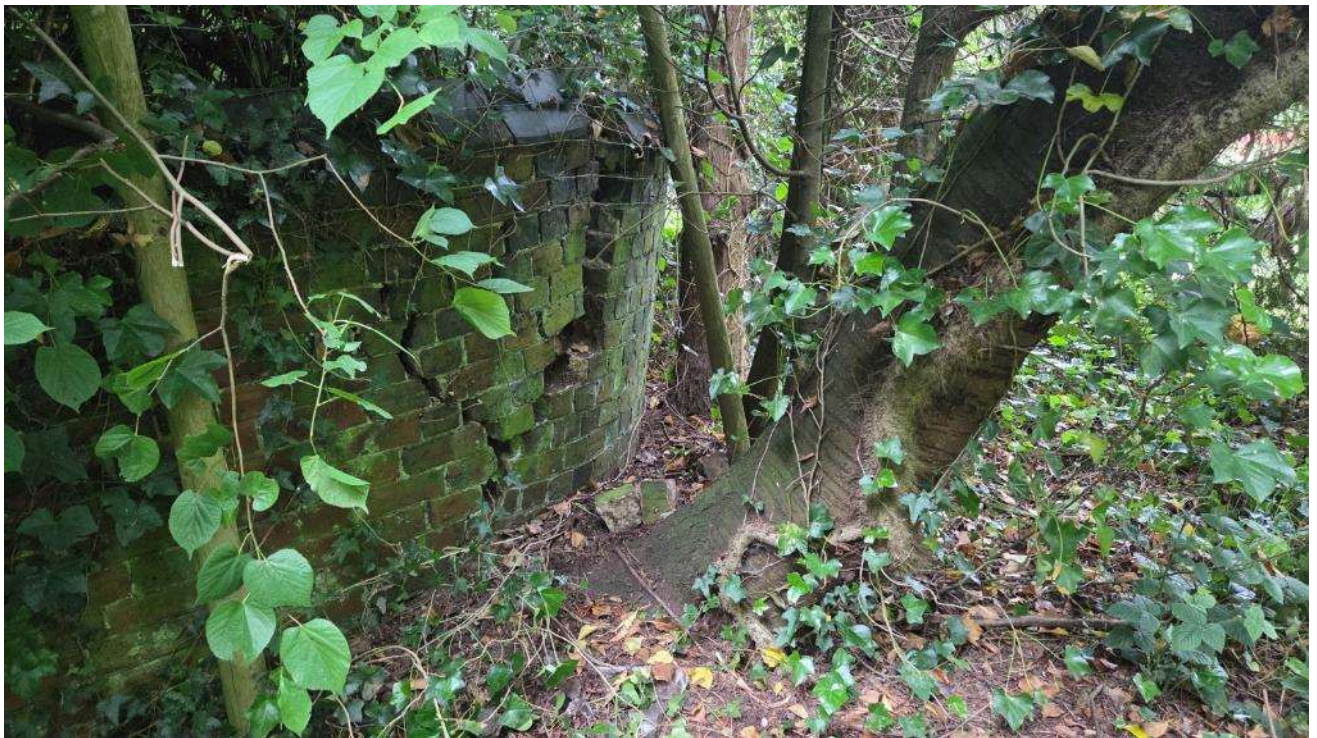
21) Same corner as 20) with loose and rotated masonry. Tree base from garden side in foreground.

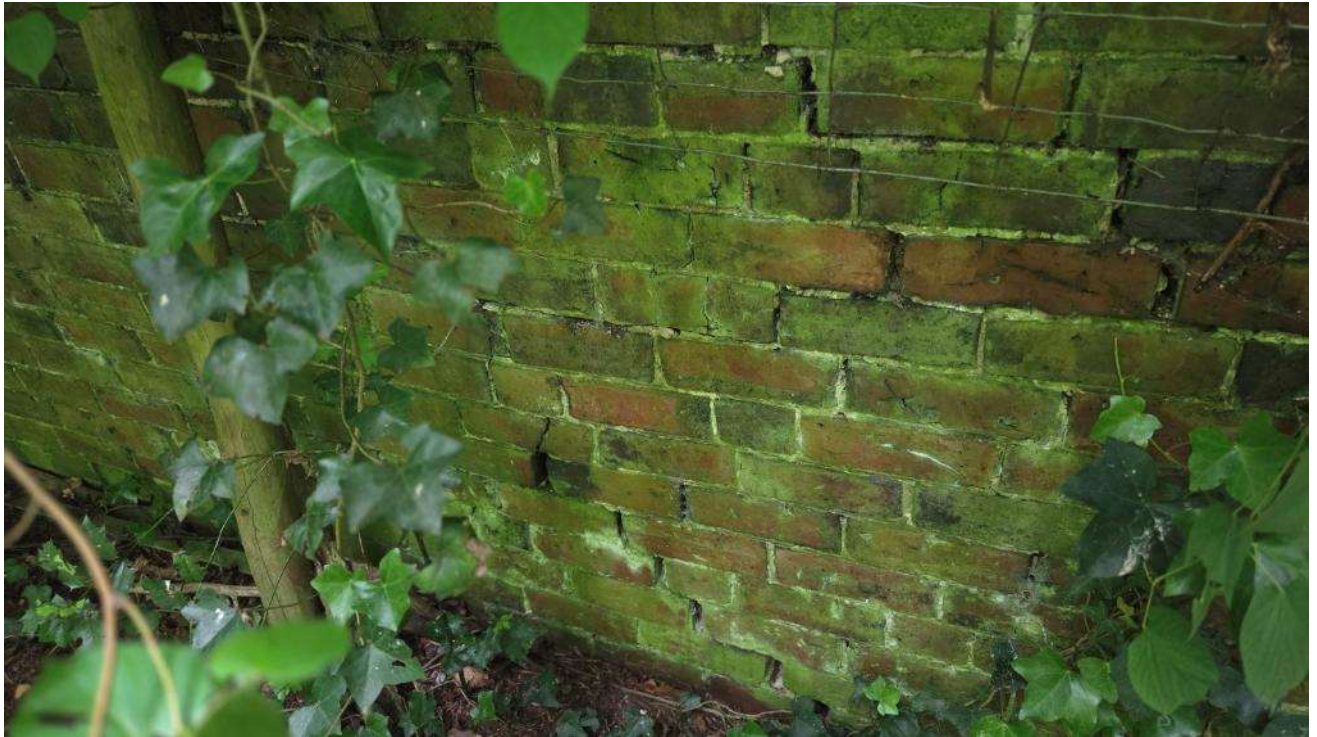
22) Near corner residual cracking from rotation.

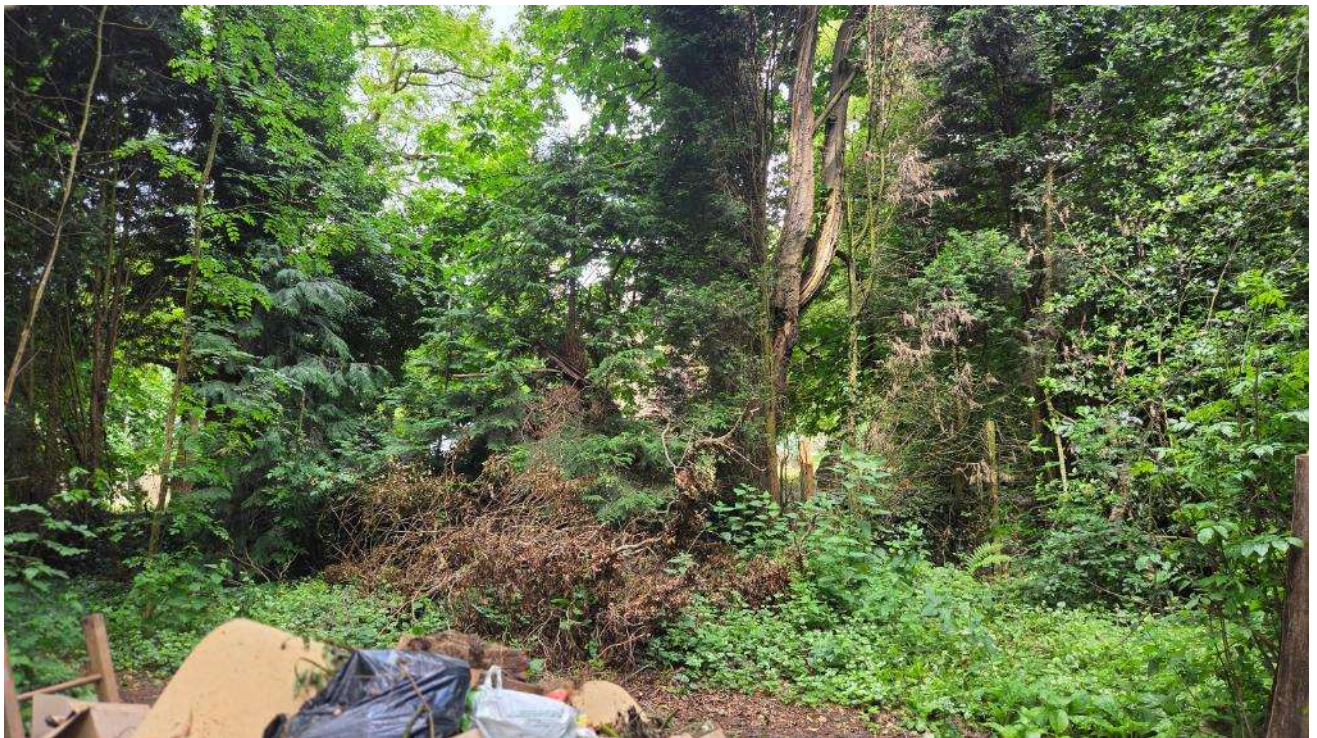
- 5.15 The wall reduces in height, (690mm below the top coping), not being particularly much higher than the churchyard ground on the other side.
- 5.16 A large bough of a dead tree in the churchyard has fallen into the adjacent property.
- 5.17 The boundary returns east but comprises a mixture of hedge rows and wire fencing.

23) Dense tree growth at east boundary with large branch section from churchyard side fallen onto property from churchyard side.

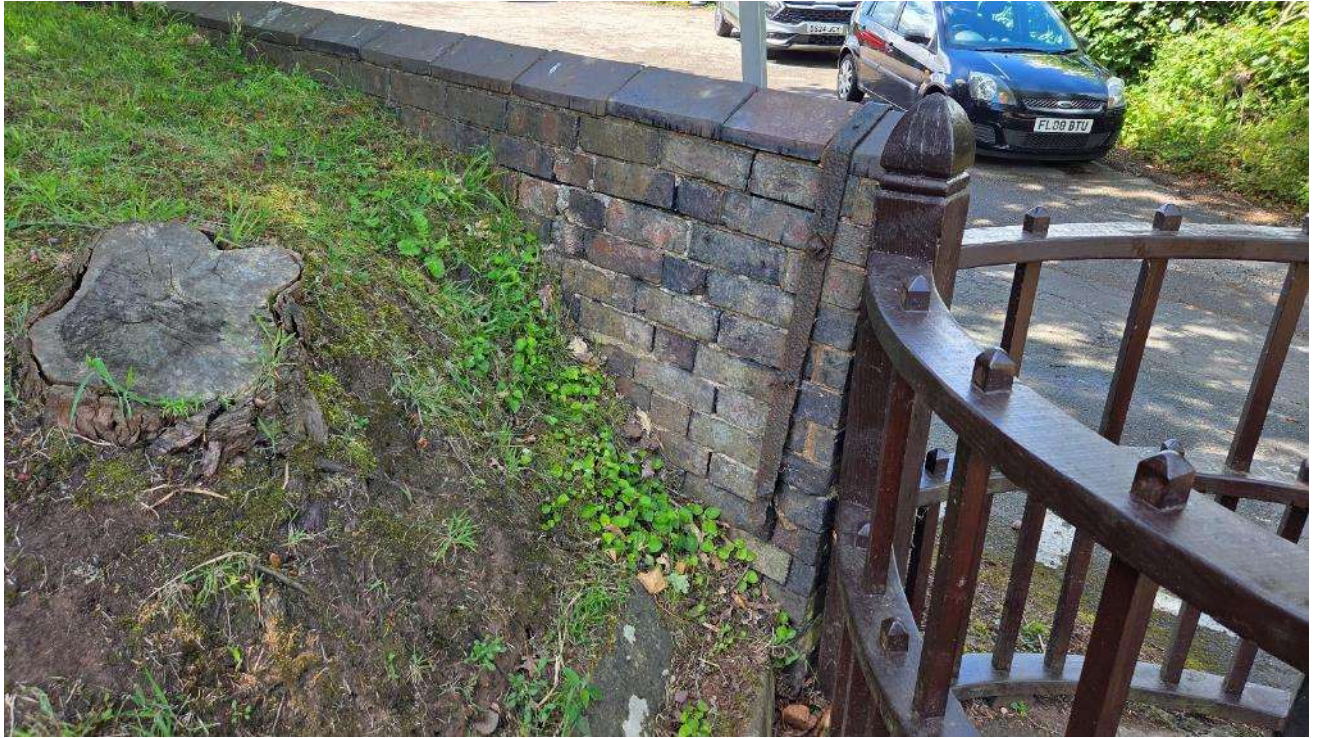
28) Entrance gateway with wall pushed by previous tree growth. Older iron strap bolted to end of the wall. Wall rapidly retains ground.

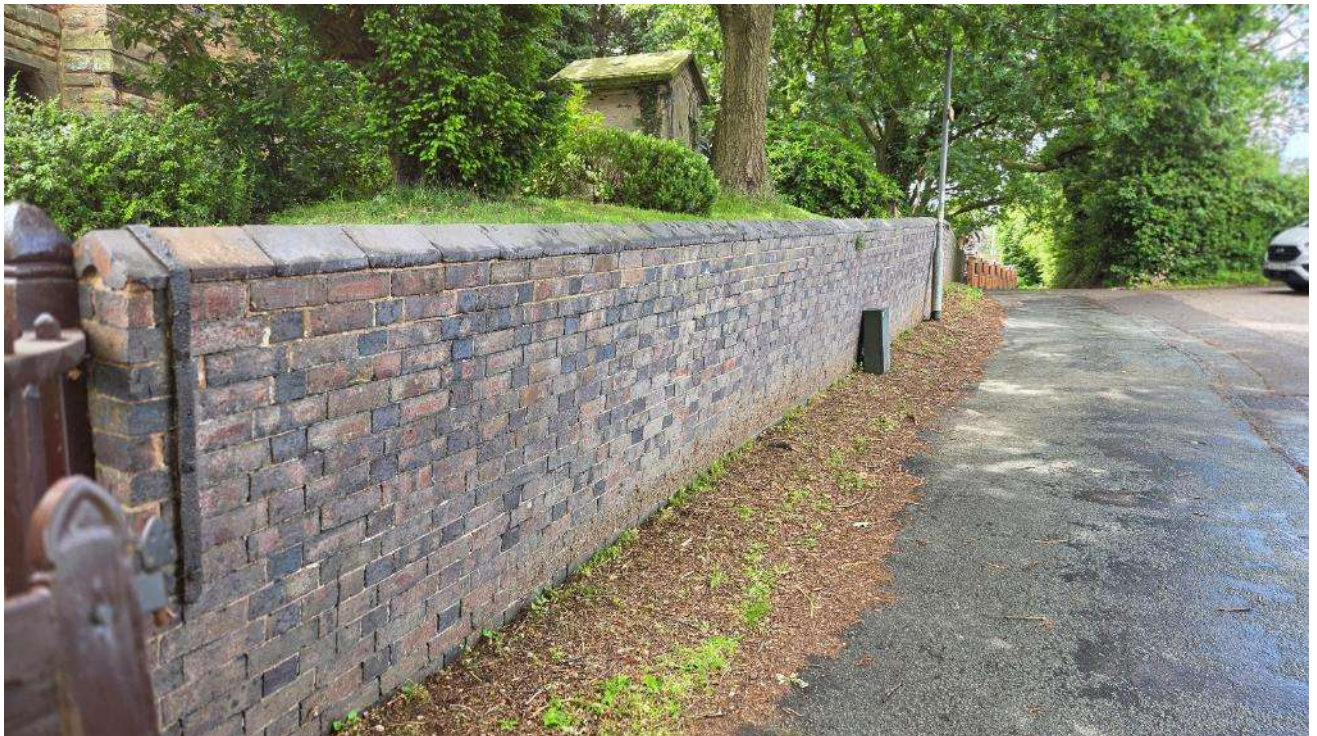
- 6.5 The wall leans outwards along its entire length up to 155mm out of plumb between a green “comms” metal box in the road and a lamppost. The top of the wall touches the edge of the lamppost.

29) Retaining wall leaning towards lamppost leans further.

- 6.13 The lean to the wall is up to 6.5 degrees from plumb though generally less. The movement does appear to be historical and may not move much more. Weepholes may help and general maintenance and repairs including stitching across cracks with stainless steel Helibar type reinforcement 500mm each side would help its continuity. There are no movement joints as is expected of a wall of this age.
