HWA (Structural Engineers) Limited

20646/BGS- L -01

## **St John the Baptist Church, Hammerwich – Structural Inspection of Churchyard boundary walls and structures.**

## St John the Baptist Churchyard Hammerwich - Photographs

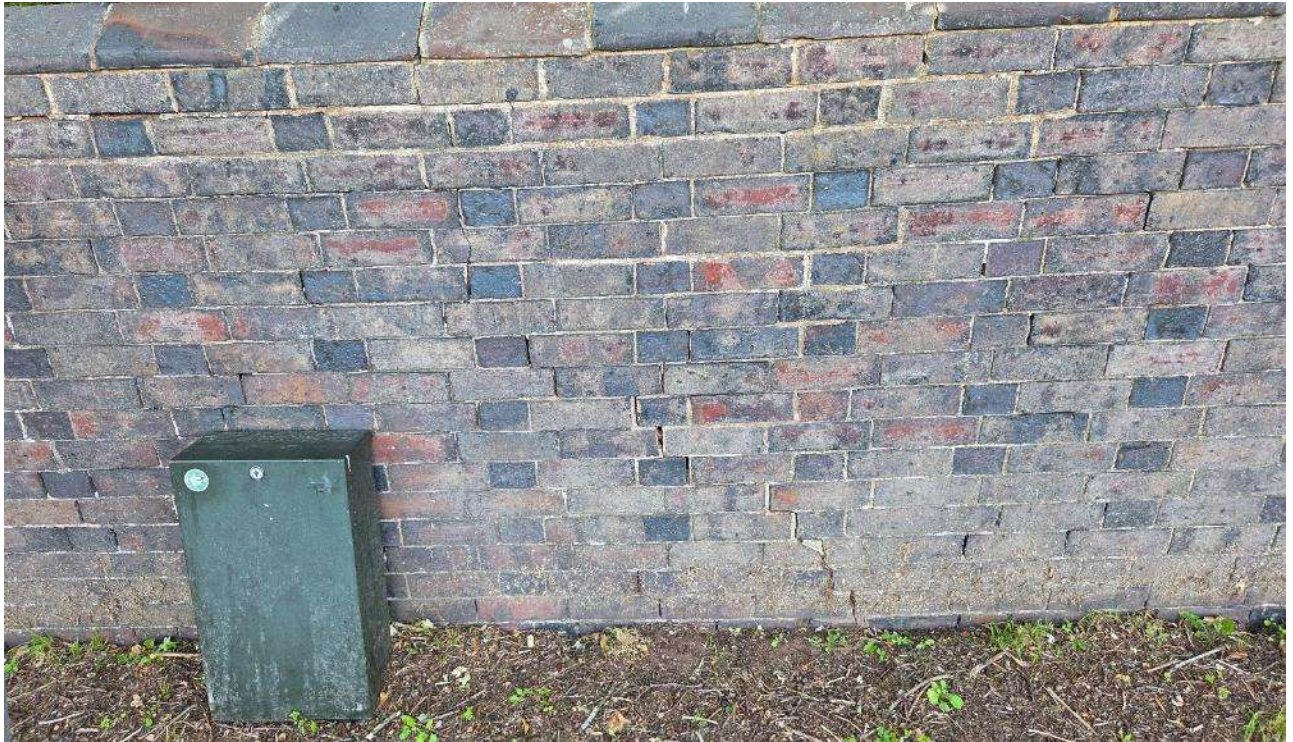
- 6.6 Apart from the lean to the wall there are also near vertical or diagonal cracks to the masonry in a few areas. These occur where the lean becomes greater or in one case there is a large tree behind. The cracks are not large.

30) Leaning wall section with diagonal and vertical cracking from base as section to right and lamppost

- 6.13 The lean to the wall is up to 6.5 degrees from plumb though generally less. The movement does appear to be historical and may not move much more. Weepholes may help and general maintenance and repairs including stitching across cracks with stainless steel Helibar type reinforcement 500mm each side would help its continuity. There are no movement joints as is expected of a wall of this age.

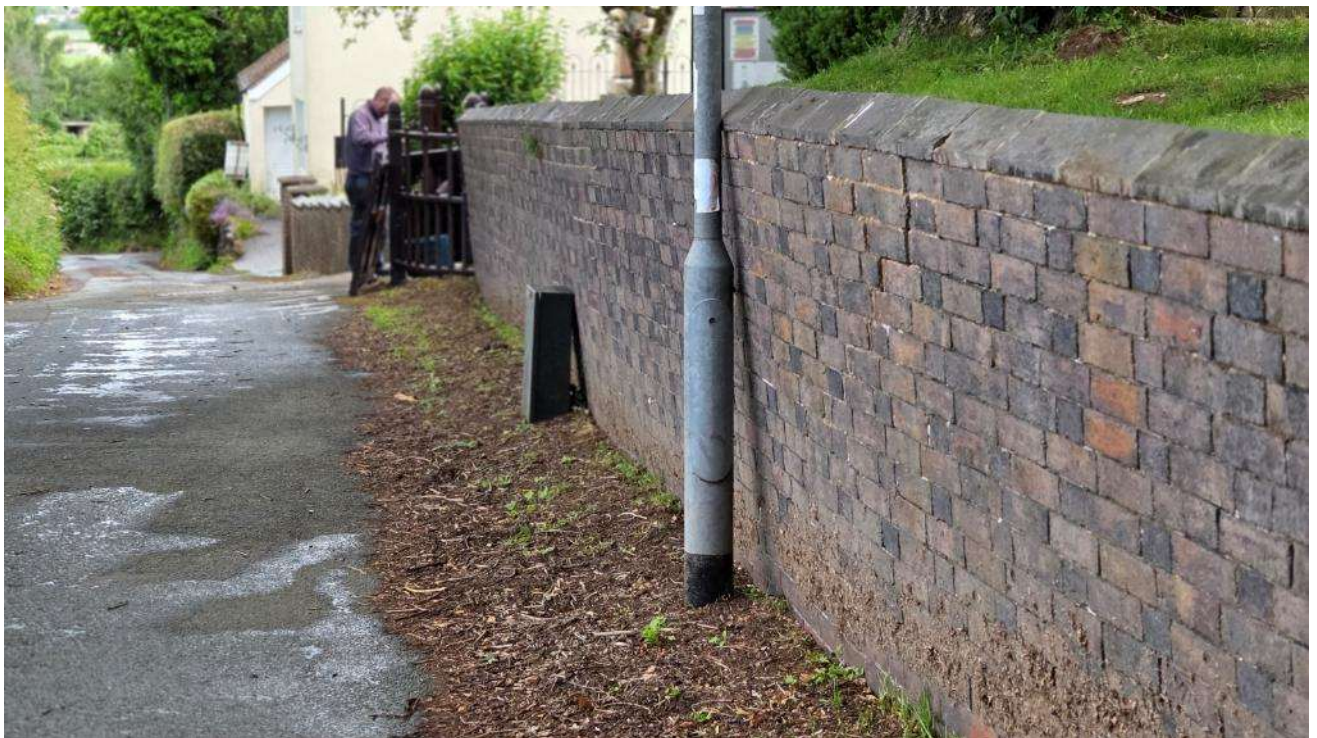
31) Top of wall touching the lamppost with slight stepped crack seen to right at the top of the wall.

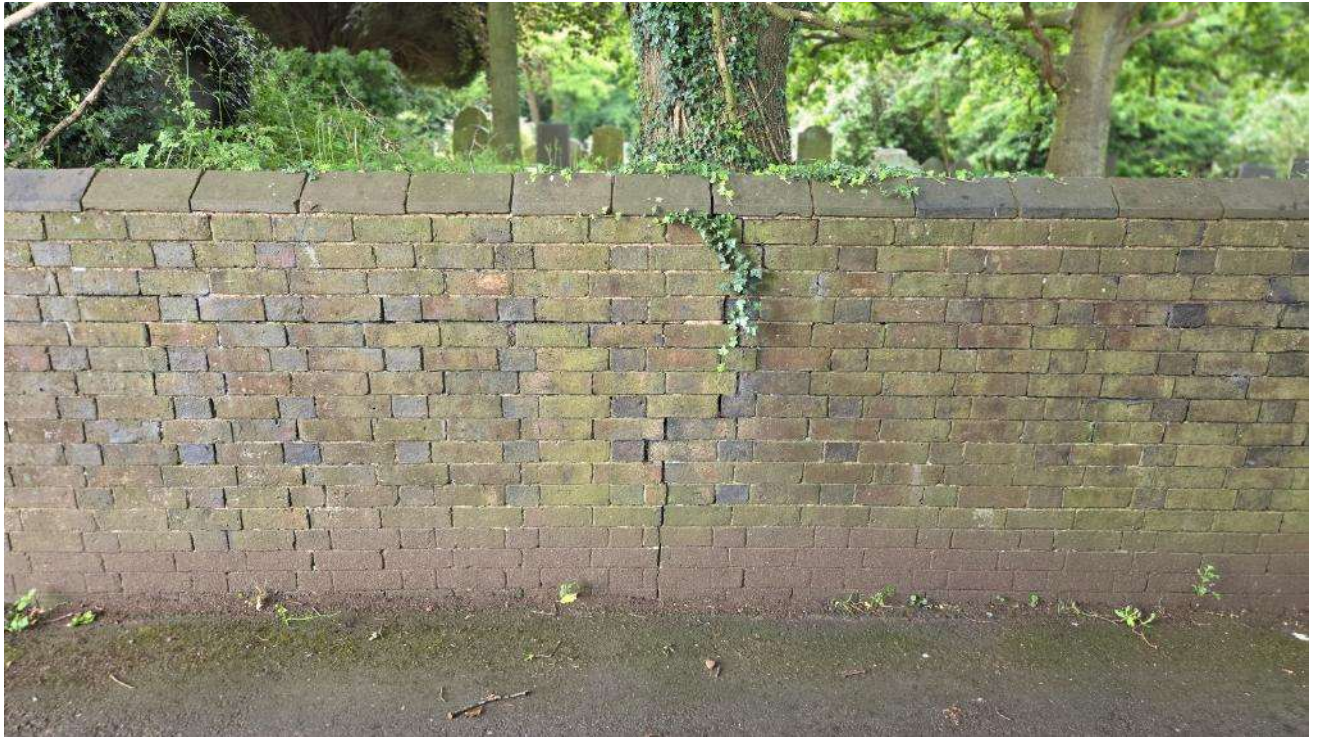
32) Near vertical crack further to the east in front of tree.

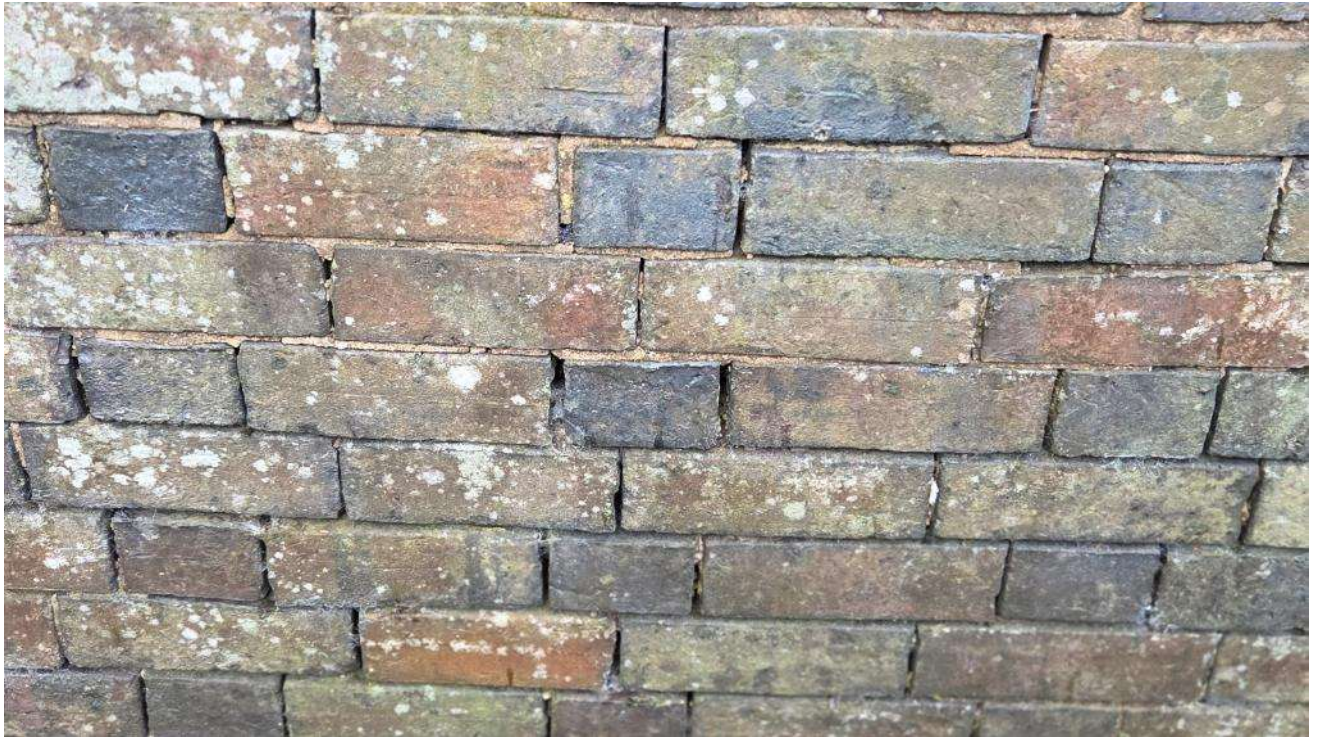
- 6.7 Further to the south there appears to be some mortar loss in the face of the wall although not tremendously deep.
- 6.8 Near the far south end a further crack has some displaced brickwork on either side although less visible at the coping.

34) Typical open jointed section of wall to central and southern end.

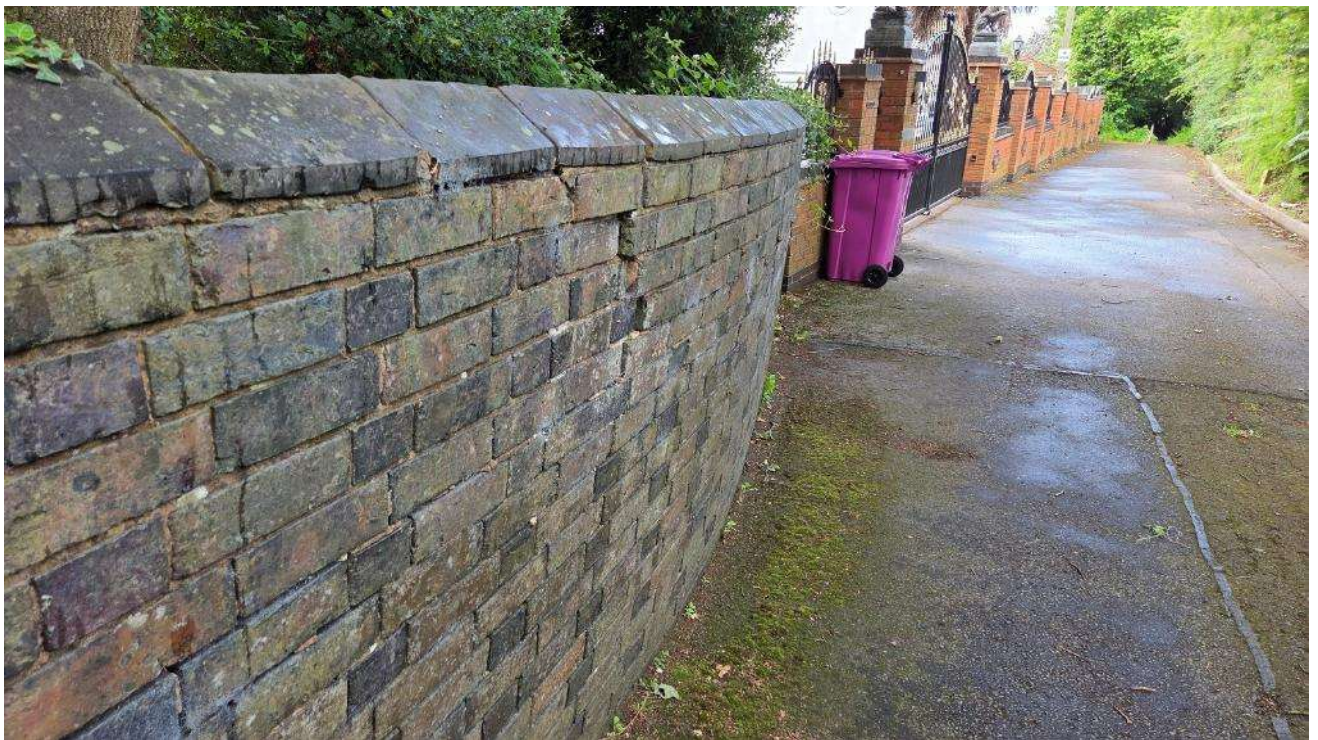
35) Cracked and displaced wall section towards south end.

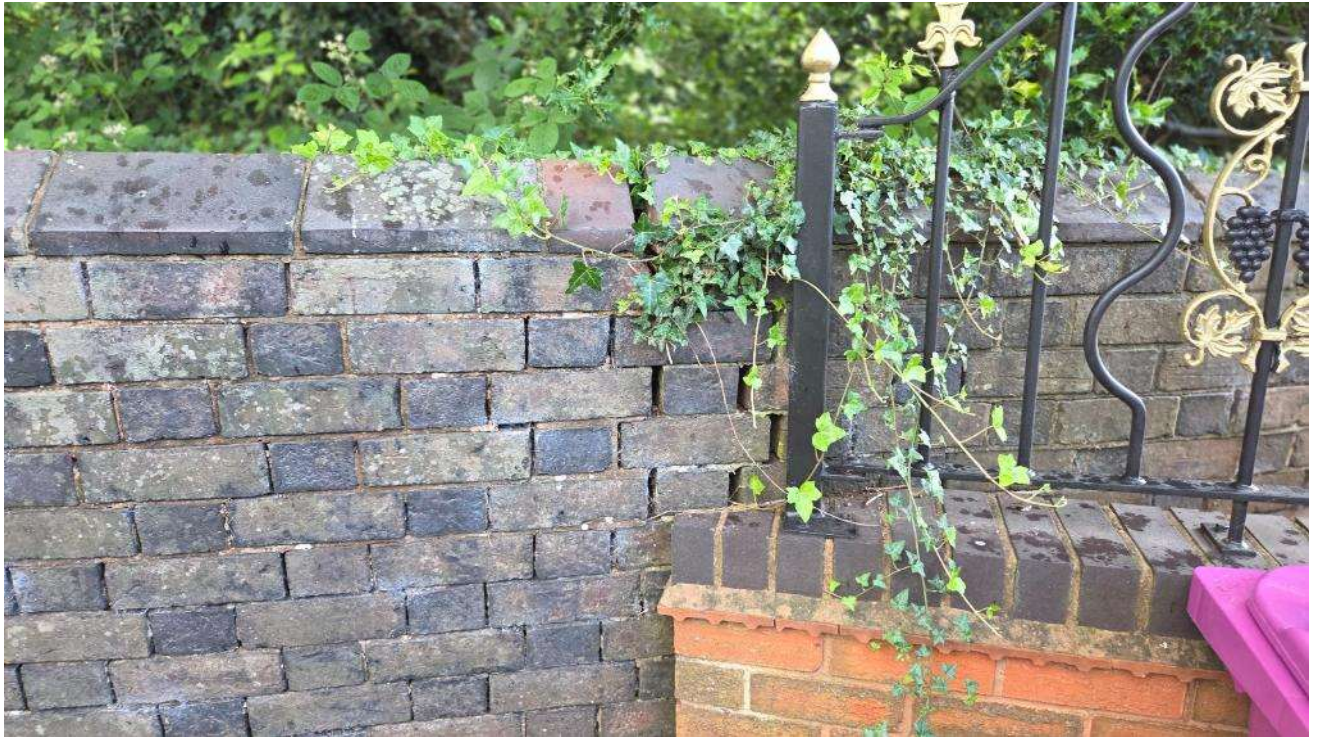
- 6.9 Where the wall adjoins the front garden wall of the Green Field property the new wall appears to be toothed into the older wall. Above this level the joints have opened up in the existing wall with ivy growth. The new wall could have formed a hard spot in the ground with a new foundation and the existing wall settled slightly on either side. It is, however, stable.

36) Open joints and slight movement where Green Fields wall is partly built into retaining wall.

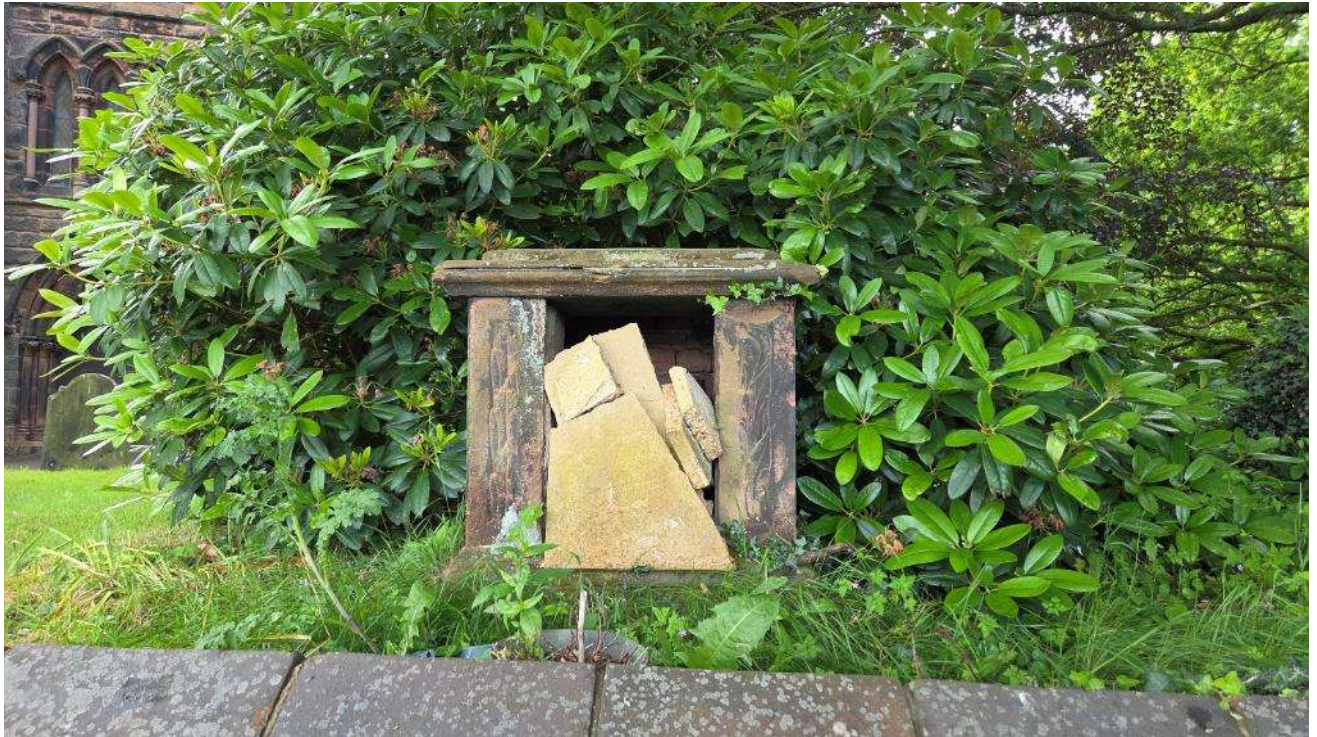
9.4 A few above ground “grave” structures were in a poor condition with cracked stonework but could only pose a particular danger if lying next to them for instance. These tended to be particularly old graves.

38) Cracked stonework to “tomb” facing Church Lane

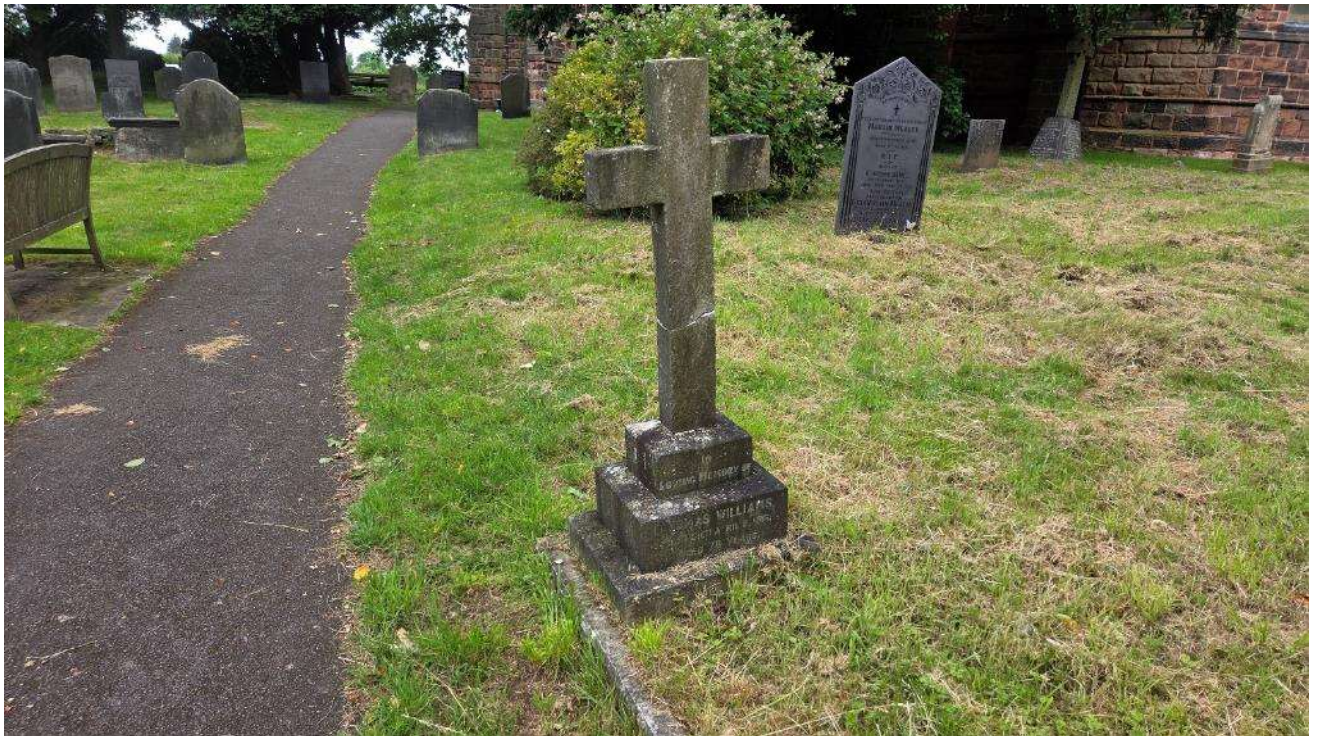
9.6 One headstone had cracks through the cross but appeared to have been dowelled and resin fixed together.

41) Cracked through cross presumably fixed together with a steel dowel.

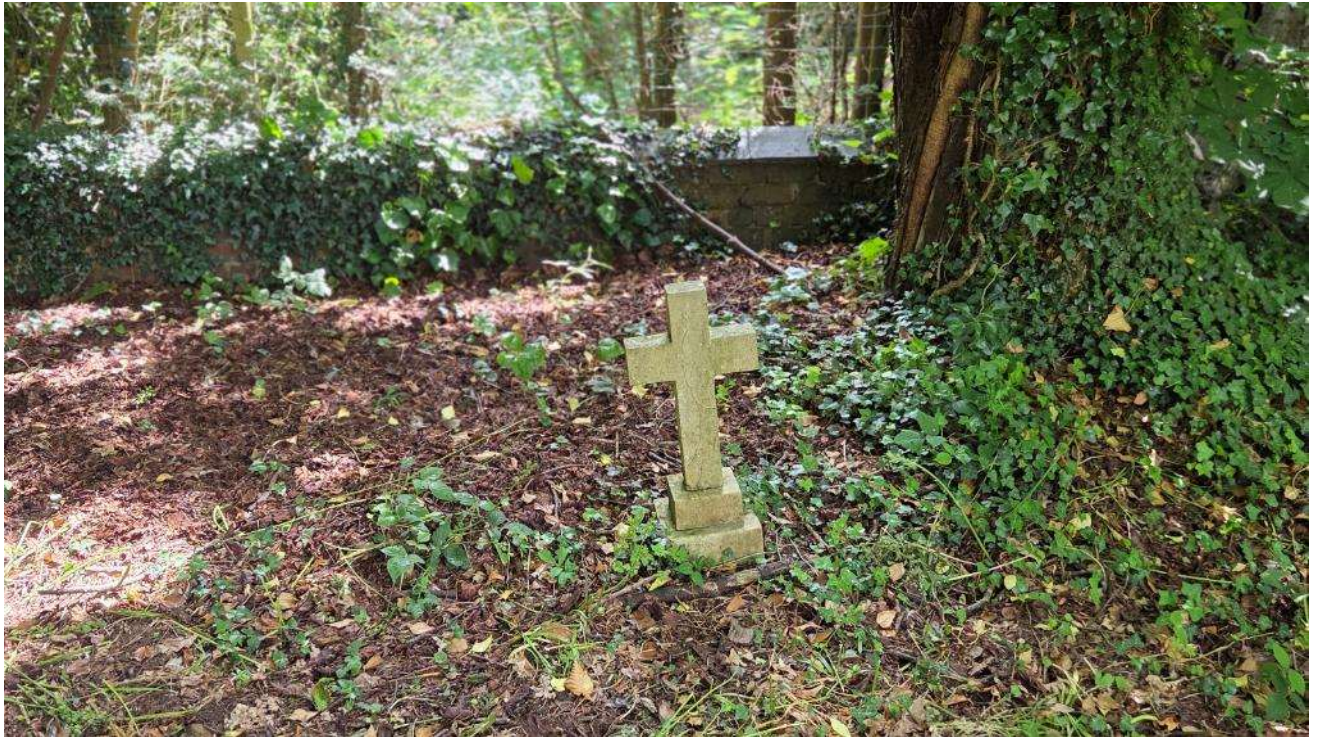
9.5 A few smaller headstones were not actually secured to the base and could be lifted.

42) Small loose headstone towards NE boundary.

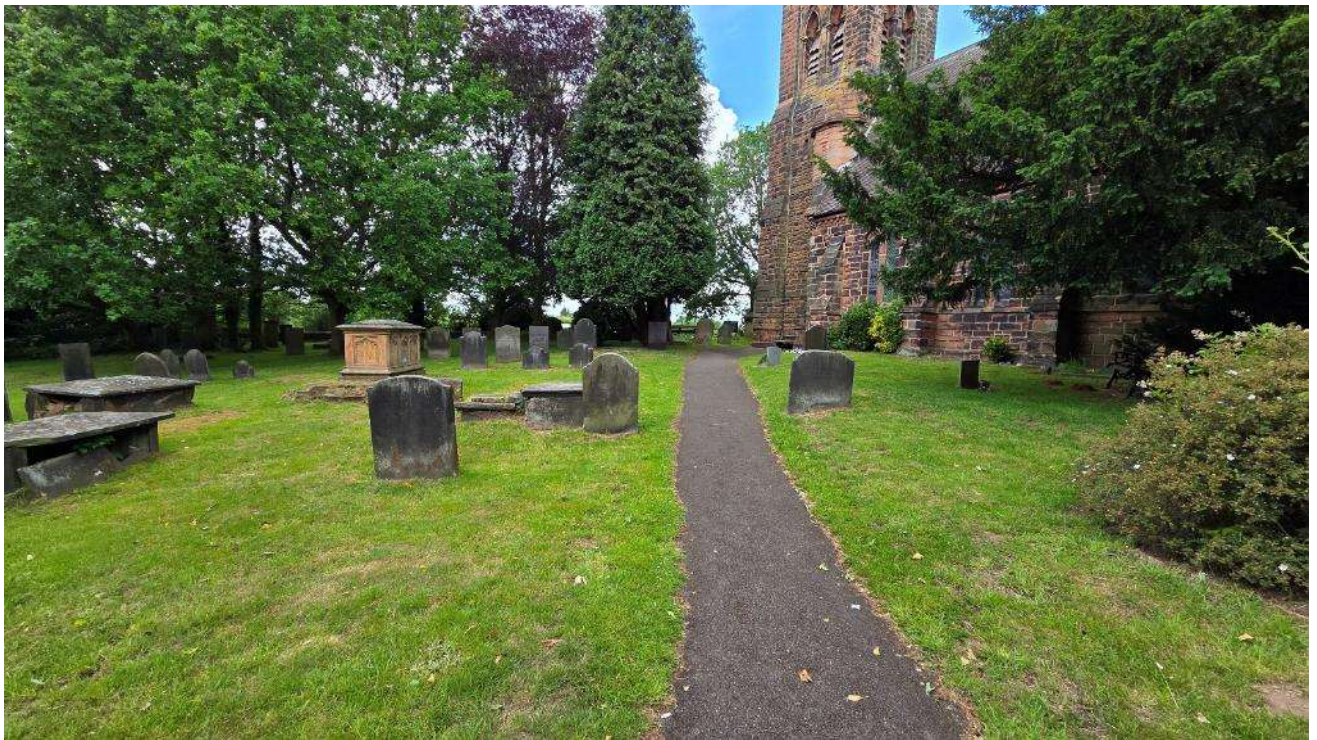
44) Cracked stonework above to above ground graves to the left.

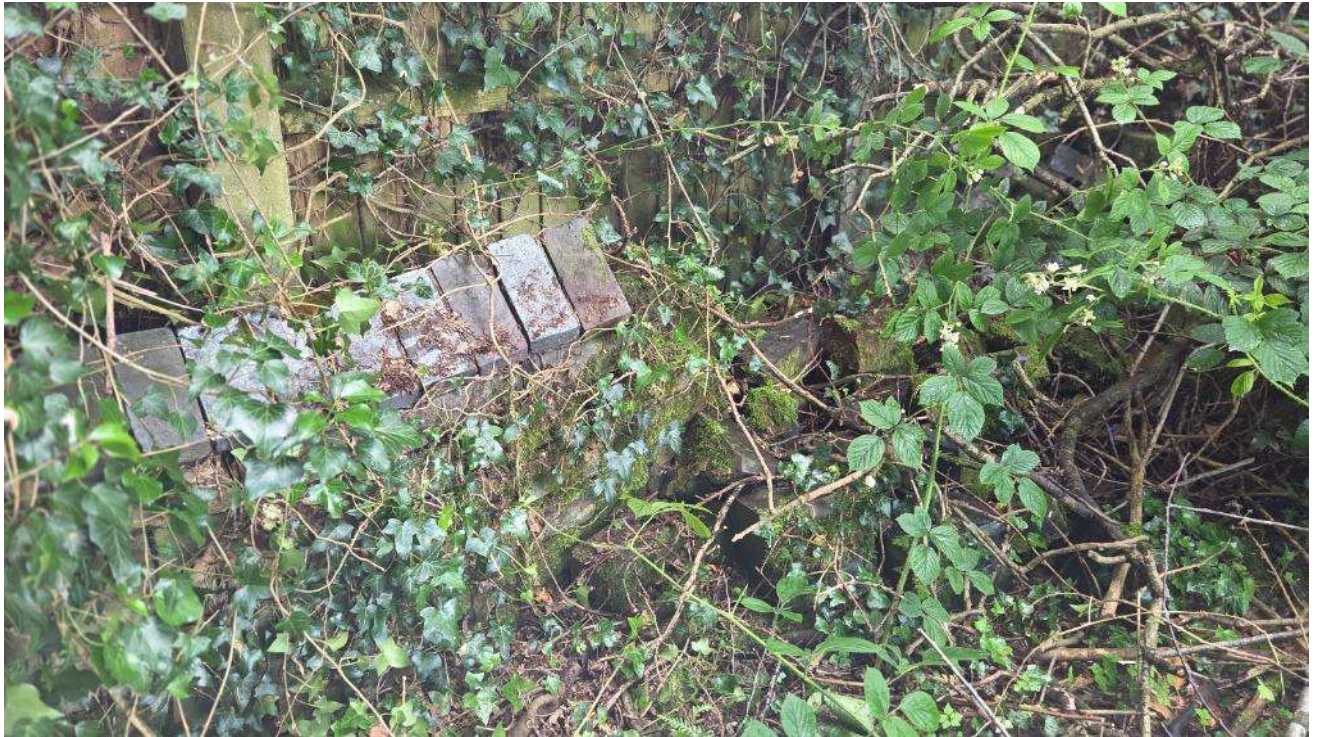
8.2 The wall is in poor condition in parts as seen in photo No 46. Where the top section has collapsed.

46) Collapsed top section boundary wall to the south retaining some ground with fence line of adjacent Green Fields close to the rear of the wall.

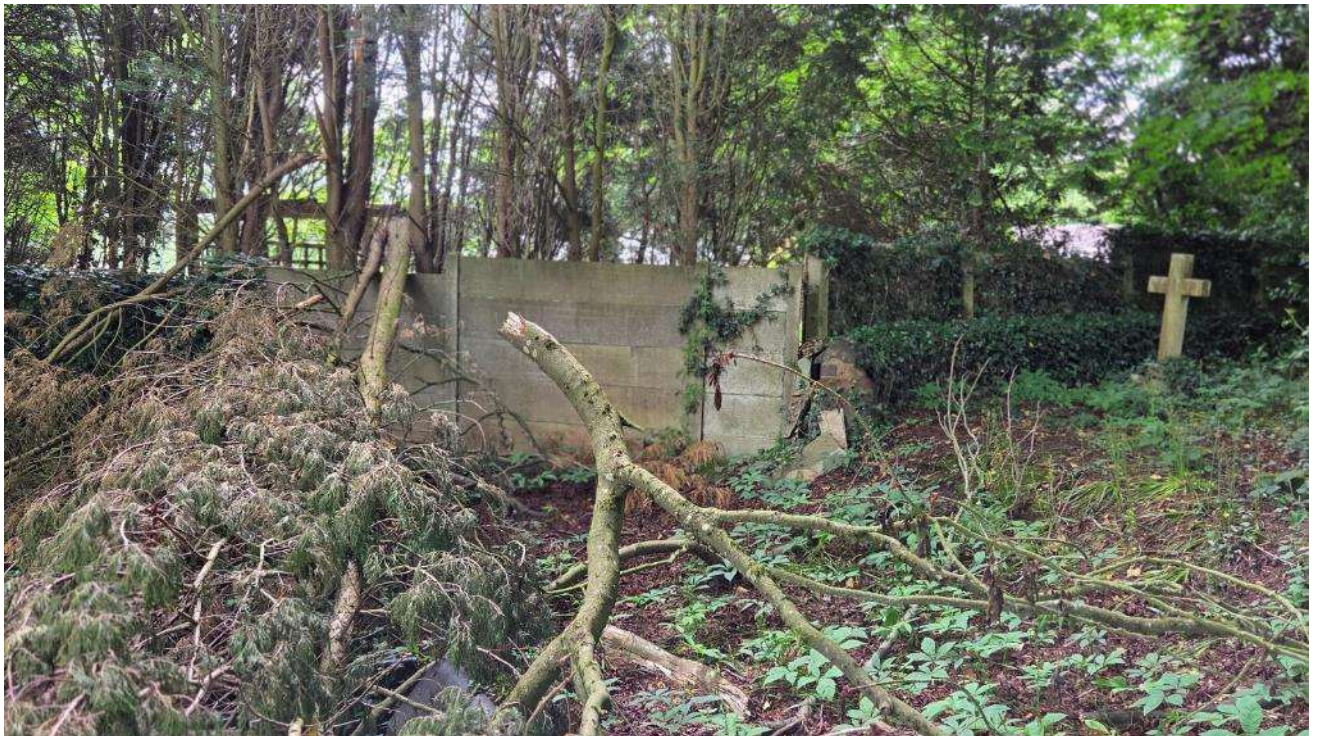
8.3 Further east the wall is replaced with a precast concrete post and panel wall for a short section before changing to an iron fence at the wood at the SE corner. (Photo No 47).

47) End of the south brick boundary wall with new precast wall section to the left (further east).

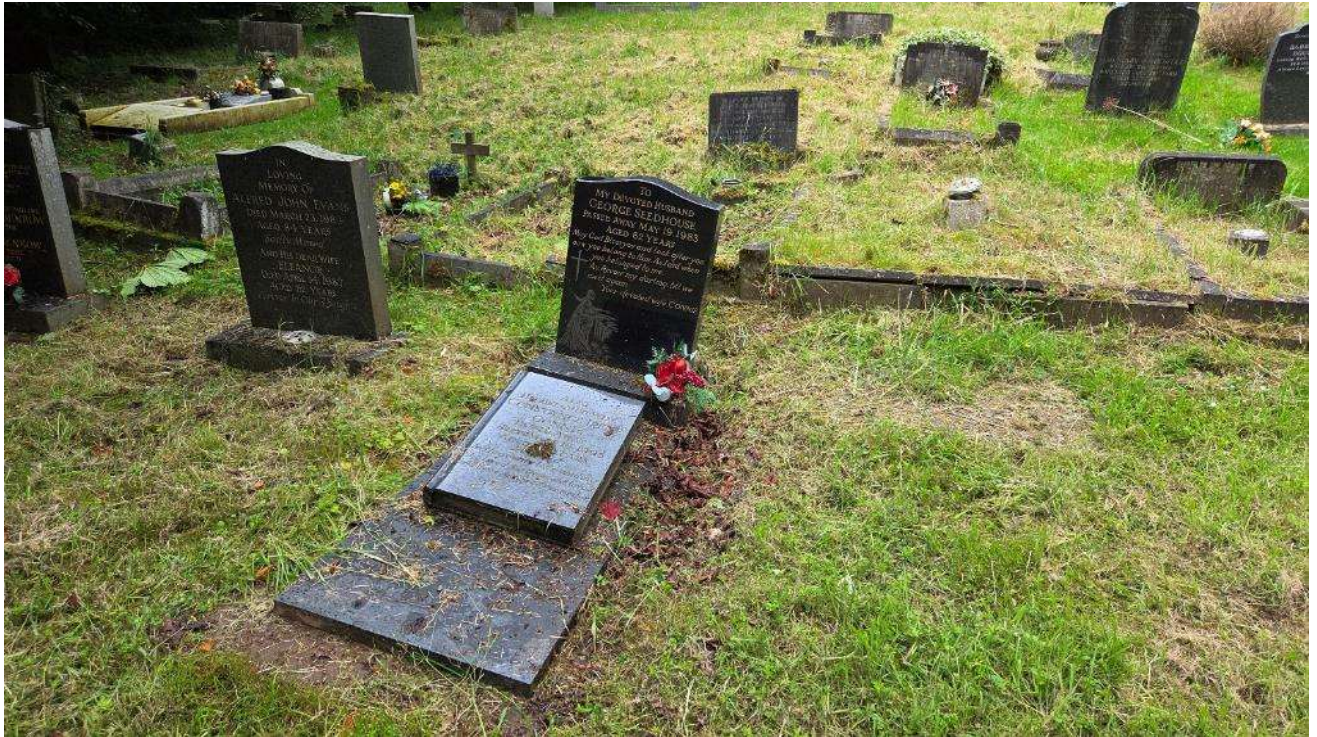
9.3 Some headstones were leaning but still felt secure whilst giving them a firm push with one arm.

48) Typical example of more recent leaning headstones to the east.
